RESEARCH ARTICLE

Bats in Churches: Objective Assessment of Associated Damage Mechanisms

James Hales*

This paper presents the preliminary results of research into the damage mechanisms involved when droppings and urine from insectivorous bats come into contact with a range of materials found within historic churches. It places the research in the wider context of conservation initiatives affecting both bats and historic church buildings in the UK.

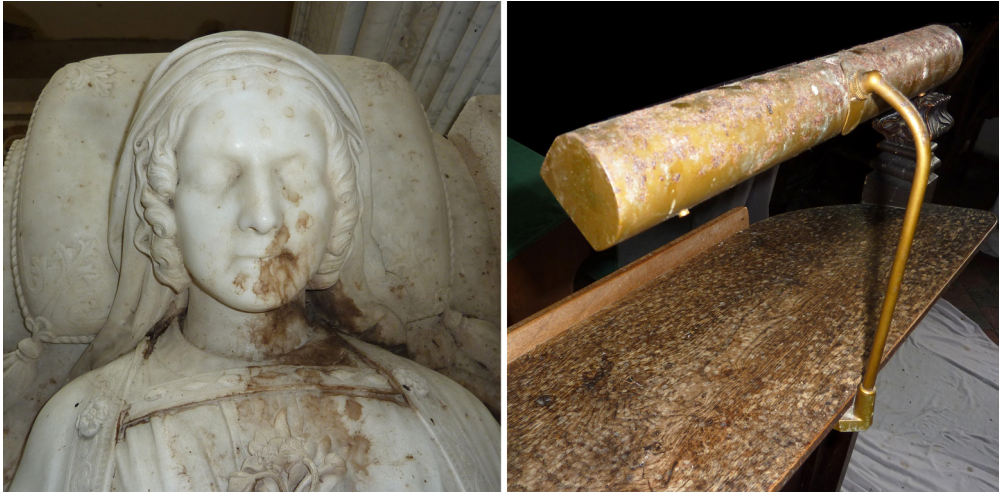
Fig. 1: Left, this marble funerary monument was situated under a bat roost, the staining has been caused by bat droppings and urine in combination. Right, this lectern shows the characteristic white spotting found on wooden surfaces caused by bat urine, the associated reading light is badly corroded.

For many years, bats have been thought to be responsible for some types of deterioration to the historic fabric of churches. However, for materials other than wall paintings, for which some research has been undertaken (Paine, 1991), our current understanding of bat related damage extends no further than being able to observe corrosion of metals, pitting of polished stone, white marks on varnished or polished wood surfaces and dark staining on pale coloured porous materials such as alabaster (**Fig. 1**). We do not

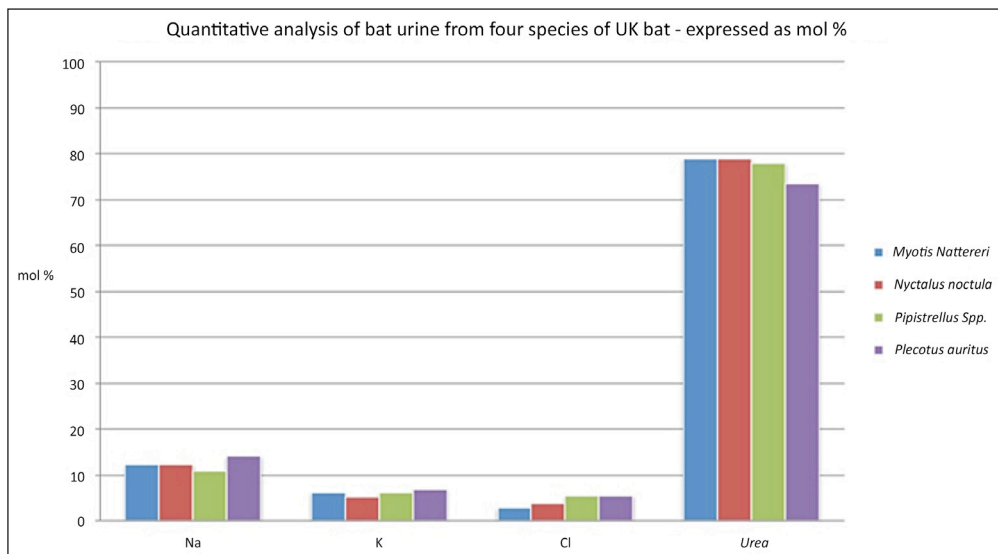
Fig. 2: Graph showing quantitative analysis of urine from four different species of bat converted to relative molar percentages for each species.

species examined. However, by expressing the concentration of the solute in each sample as molar percentages (i.e. expressing the different analytes as quantities relative to each other) (**Fig. 2**) it can be seen that the components of the bat urine analysed show a good degree of consistency across the four species, with little to no variance beyond the calculated standard deviation. What this means, is that urine composition is broadly consistent across all four species, yet the concentration of the urine is not.

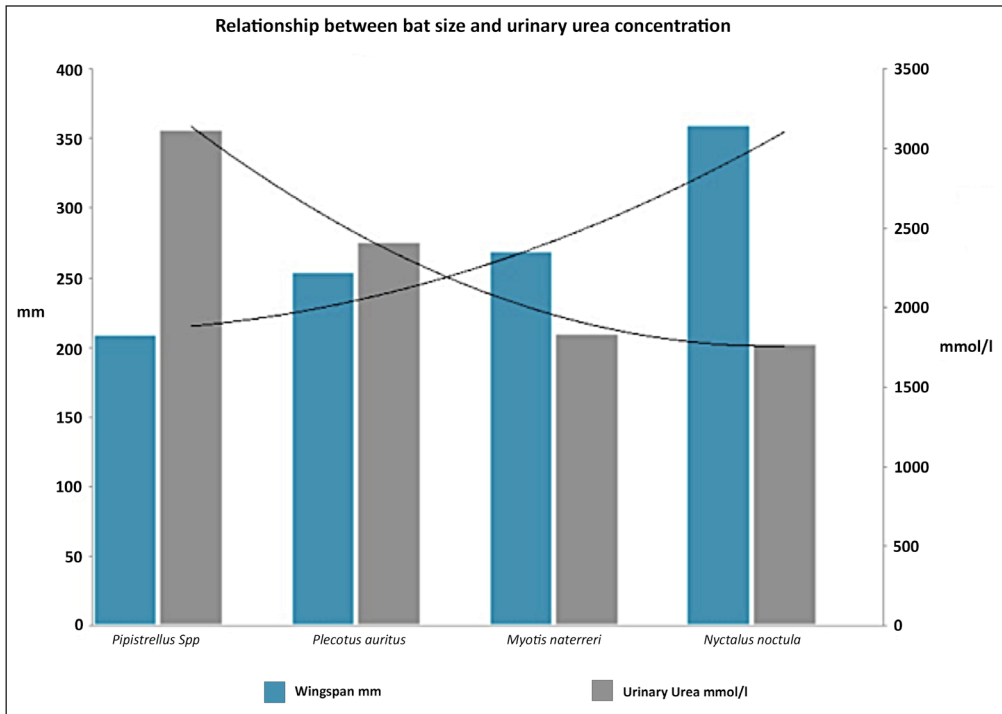
Fig. 3: Graph showing the inversely proportional relationship between bat size (represented by wingspan in mm) and urea concentration in mmol/l. To further highlight the relationship, polynomial trend lines are shown for both wingspan and urinary urea.

What is most striking about the data is that the concentration of the urine is inversely

proportional to the size of the bat, with larger bats producing more dilute urine. **Fig. 3** shows the relationship between bat size (represented by wingspan) and urea concentration - the relationship between the two parameters can clearly be seen. If the solutes detected are found to play a significant role in deterioration mechanisms, then clearly their relative abundance in the urine of different species of bat will be a factor affecting the levels of deterioration that might be expected from roosts of different species.

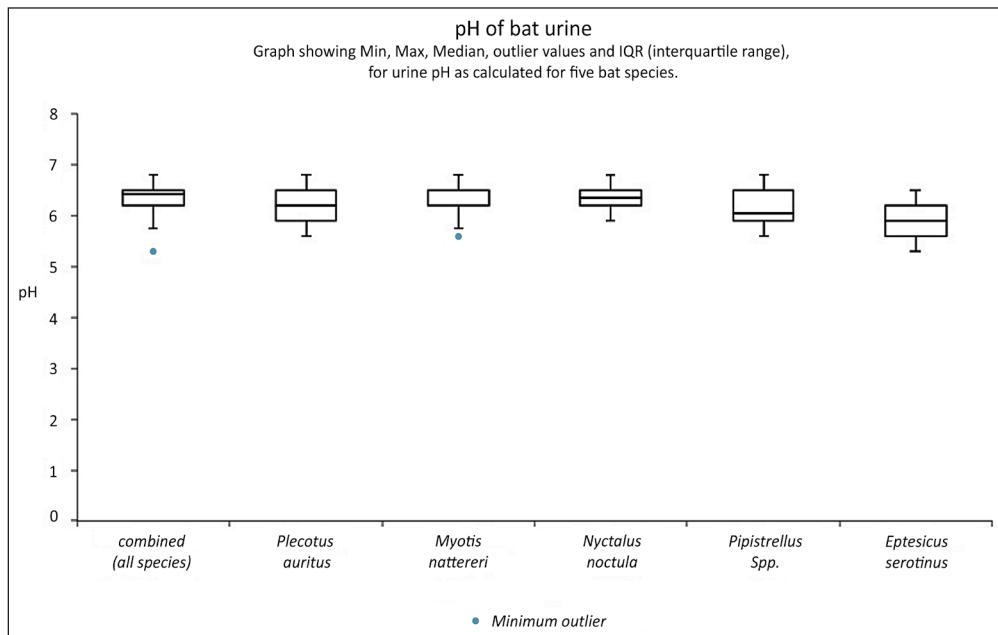
Fig. 4: Median Dq plot showing urine pH ranges obtained for five UK bat species. The graph is a “box and whisker” plot. The “whiskers” show the minimum and maximum pH values recorded for each species, the interquartile range (Q_3-Q_1) shows the distribution of the middle 50% of the data points and is represented by the “box”, the median value shown by the horizontal line appearing inside.

four species listed above). A combined total of 73 individual pH readings were recorded (**Fig. 4**). pH measurement was conducted on my behalf by licensed bat workers, measurements were taken from fresh urine collected as before from captive bats.

As can be seen, pH ranges for all species tested are broadly similar with a total range for all readings between pH 5.3 - 6.8. Technically speaking all these values fall within a pH range that would be described as acidic, however to provide some context, bottled drinking water sold in the U.K. has a pH that ranges from 4.2 – 8.7 depending on source (Bucksc, 2005) and de-ionised water used in conservation laboratories commonly has a pH of 5.5. Therefore, while the pH of bat urine is acidic, it is only mildly so. Although it should be noted that long term exposure to mildly acidic solutions can be problematic for some materials (for example calcareous stone), my findings do not

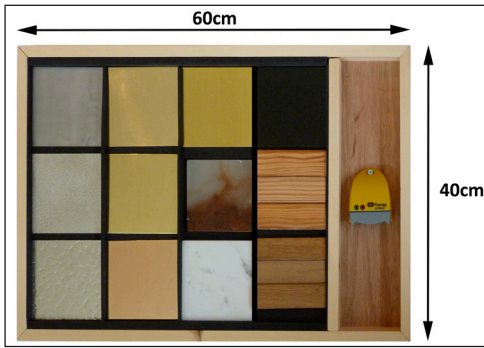
Fig. 5: Sample board prior to deployment and positioning of protective elements to partly cover the test samples, and showing the data logger.

The sample boards consisted of wooden trays 60cm x 40cm holding prepared samples of 10cm x 10cm each (Fig. 5). The design allowed for samples to be partly covered so that a section of their surface was protected thus providing a control specific to each individual test material. Each tray carried a data logger used to record relative humidity (RH) and temperature for the duration of the exposure period. This was considered important as temperature and RH would likely play a role in corrosion cycles, rates of reaction and the effect of salt crystallisation within porous substrates.

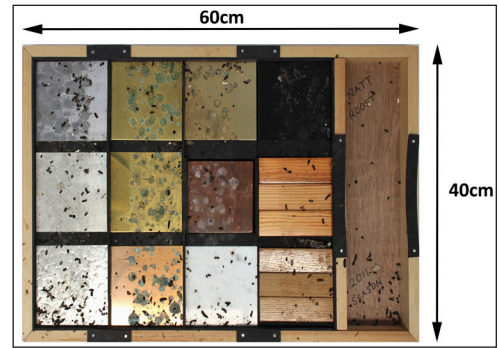
Fig. 6: Phase 1 Sample board after retrieval, the effect of bat droppings and urine on the test materials is readily apparent.

This aspect of the work represents a two-year cycle of experimental work, and has generated a dataset of 84 different sample surfaces on which subsequent analysis can now take place. While a full analysis of the test samples has yet to be undertaken, there are some interesting preliminary results. Of foremost importance is the fact that the deterioration seen on the test samples is directly comparable to that observed *in situ*, for example in the case study churches, with corrosion of metal surfaces, staining of porous materials, and the distinctive white spotting resulting from urine deposition on organic coatings (such as polishes) all seen on the test samples (Fig. 6). From initial observations it can also be seen that

investigation should focus not only on the effects of urine and droppings individually, but also on their effects in combination as it appears that this can affect both the type of corrosion seen on metal surfaces and the staining observed on porous materials.
