RESEARCH UPDATE

Eroding Heritage: An Island Context

Sue Hamilton and Mike Seager Thomas

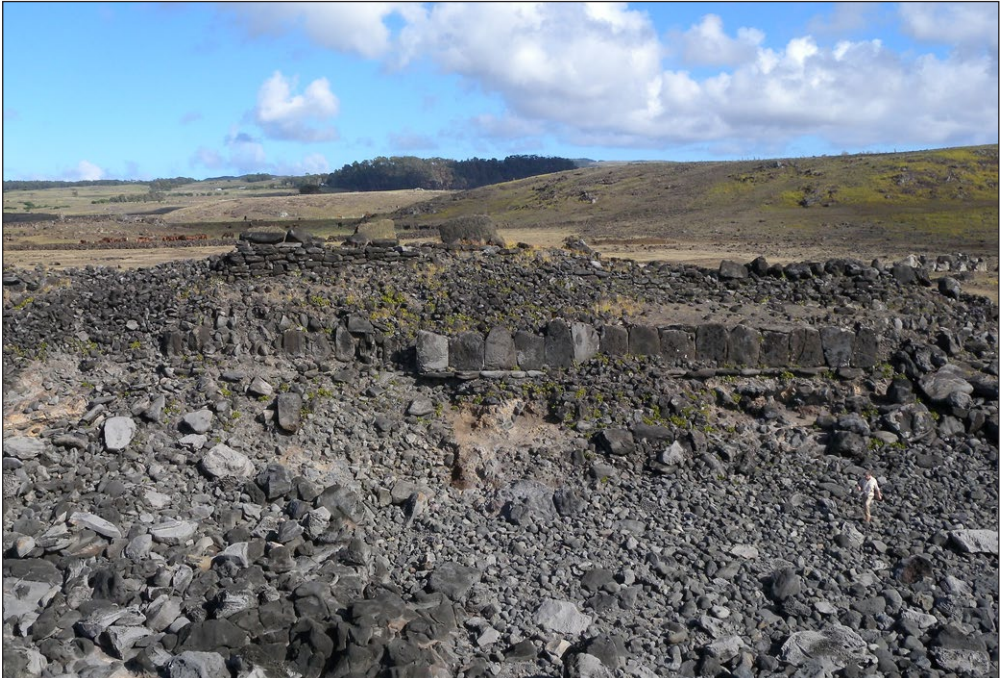
Figure 1: The rear of Ahu Ura Uraja Te Mahina, on the south coast of the Island. Sea erosion of the low cliff on which it stands has reached its rear wall, and is causing it to collapse (in the photo, the collapse is advancing from the left to the right). The bases of three prone *moai* are partially visible at the top of the surviving platform. Photo: Adam Stanford.

Coastal erosion is not a new threat to Rapa Nui heritage. Since the original construction of the *ahu* around the coast in deliberate proximity to the sea, it has slowly brought the coastline closer and closer to them. These *ahu*, on many of which *moai* once stood, and on some of which these have been re-erected, are now enveloped in sea spray and in some cases physically battered by the waves. The consequence of this is that the stones comprising them have become pitted with tafoni and—in places—are collapsing into the sea (**Figures 1** and **2**, left).

of salt. Others, also tourist attractions, but more important archaeologically because they have not been reconstructed, are being steadily degraded by ongoing wave action. For example, at Ahu Ura Uraŋa Te Mahina, a low sea cliff has reached the seaward wall of the platform (**Figure 1**), and at Haŋa Tee o Vaihu, the coastline is advancing along the platform, as well as from its back. Others, and parts of others, not on the tourist circuit but of no less importance, are already in a state of terminal breakdown.

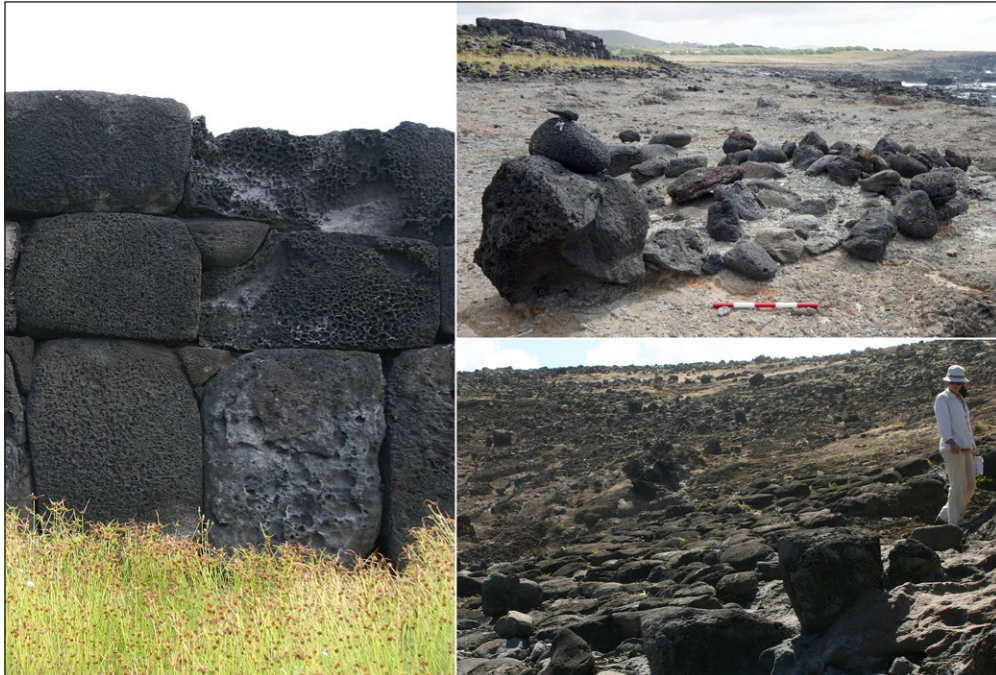
Figure 2: Coastal *ahu* are open to many threats. Left: tafoni in the rear wall of Ahu Haŋa Poukura caused by the re-crystallization of absorbed salt within the rock. Top right: also to the rear of Ahu Haŋa Poukura, the remains of a sea-washed crematorium. Bottom right: a paved route to a freshwater spring at the shore's edge at Ahu Haŋa Teteŋa, which is being degraded by wave action and by people and animals accessing the spring. Photos: Sue Hamilton (left) & Mike Seager Thomas (right).
