Semi-fortified Palatial Complexes in Central Asia: New Work at the Great Kyz Kala, Merv, Turkmenistan

Within Central Asia there is an unusual group of earthen buildings (köshks), usually constructed on raised platforms, with vertical engaged columns forming iconic 'corrugations' on the exterior walls. The complexes are semi-fortified, with a second storey entrance, and often with asymmetrical ranges of rooms around an internal courtyard. Little systematic archaeological work has taken place on these monuments, which have mainly been studied as relatively eroded standing structures. However, recent work at the Great Kyz Kala at Merv, Turkmenistan, the largest surviving monumental köshk in Central Asia, has provided more details of construction and use. The excavations suggest that this complex was constructed in the 8th/9th century CE, with well-appointed rooms on the second storey, including a large hall, and functional rooms and storage spaces around a courtyard on the lower floor. The complex was set within an enclosure, containing gardens and possibly ancillary buildings. This particular köshk may have acted as an elite palatial suburban residence, perhaps for the governor of M

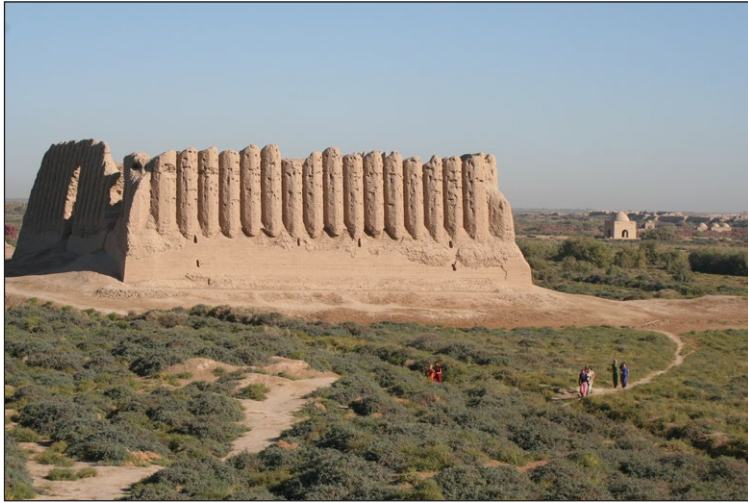
Figure 1: The Great Kyz Kala in 2006, with the walls of the city of Sultan Kala in the distance (right) (Photograph Gaygysyz Jorayev).

The exterior walls are visually striking, with the massive engaged columns forming the distinctive corrugations (**Figure 1**). The north and west walls are the most eroded, although enough remains to indicate the original position of the corrugations. The east and south sides, protected from the prevailing winds, survive in remarkably good condition. There were 22 corrugations on the longer east and west façades, and 18 on the slightly shorter north and south sides of

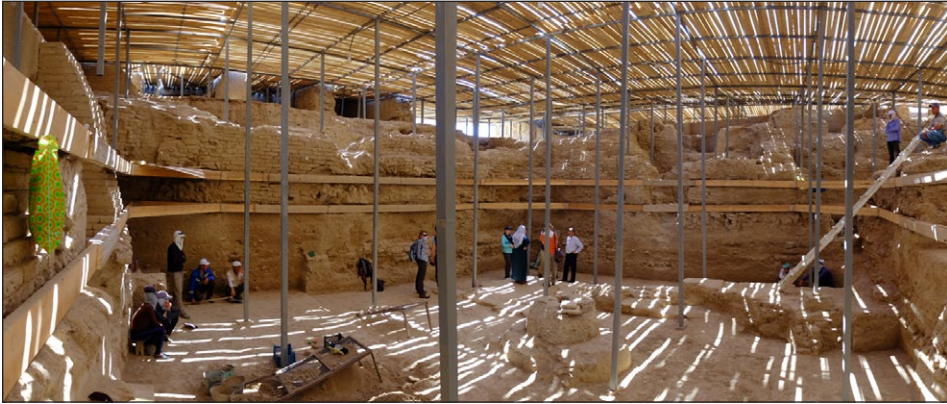
Figure 3: Looking southeast within the Park's excavations within the courtyard area, with a temporary shelter to protect the site (Photograph Sébastien Moriset).

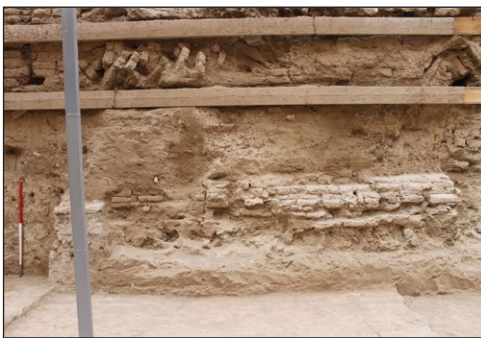
Figure 4: The eastern section of the courtyard, showing the platform of compact earth, beneath the base of the walls in section. (Scale 1 m) (Photograph Katie Campbell).

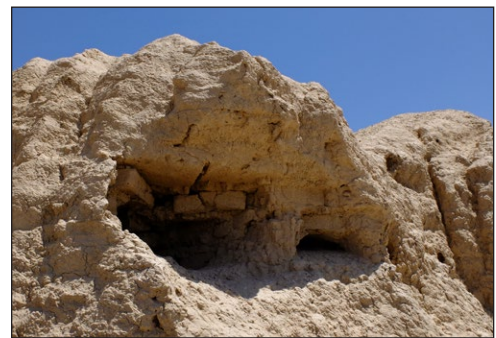
Figure 5: Cavities at the top of the southwest corner, which could correspond to the position of beams supporting a turret (Photograph Sébastien Moriset).

Archaeological evidence on the upper corners (except the northwest, which is too eroded to have survived) (**Figure 5**) suggests that there may have been wooden towers at the corners of the complex (**Figure 7**).

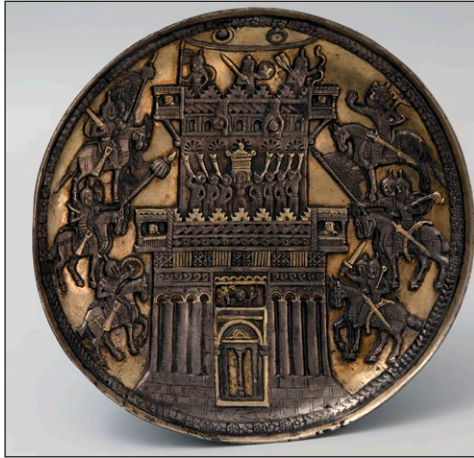
Figure 6: A silver gilt dish, shows a fortified building under attack. Note the doorway, corrugations, crenellations and corner towers. It is not clear if the illustration is trying to show perspective (i.e. the far wall of a roughly square building), or a higher central tower, although differences in towers and parapet perhaps suggest the later (The State Hermitage Museum, St. Petersburg: inventory number S-46). (Photograph © The State Hermitage Museum. Photograph Svetlana Suetova).

A silver gilt dish, possibly a 9th- or 10th-century CE copy of an 8th-century CE original (**Figure 6**) (Marschak 1986: plates 209–211) depicts a very similar corrugated structure, with wooden corner towers, supported by timber.

Pugachenkova suggested a date for the Greater Nagym Kala of the 6th–7th centuries CE on the basis of structural details, layout, size and archaeological material found within the walls (although that was not published) and suggested a similar date, on stylistic grounds, for the Great Kyz Kala (Pugachenkova 1958: 134). The Hermitage dish (**Figure 6**), supposedly a 9th- or 10th-century CE copy of an

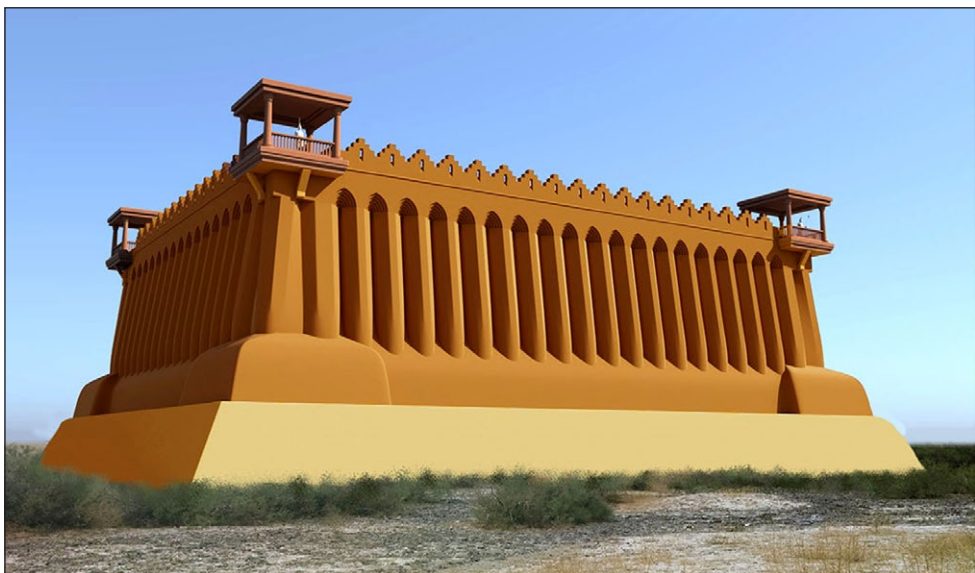
Figure 7: Interpretative reconstructions of the Great Kyz Kala, with corner towers (reconstruction by the Ministry of Culture, Turkmenistan).

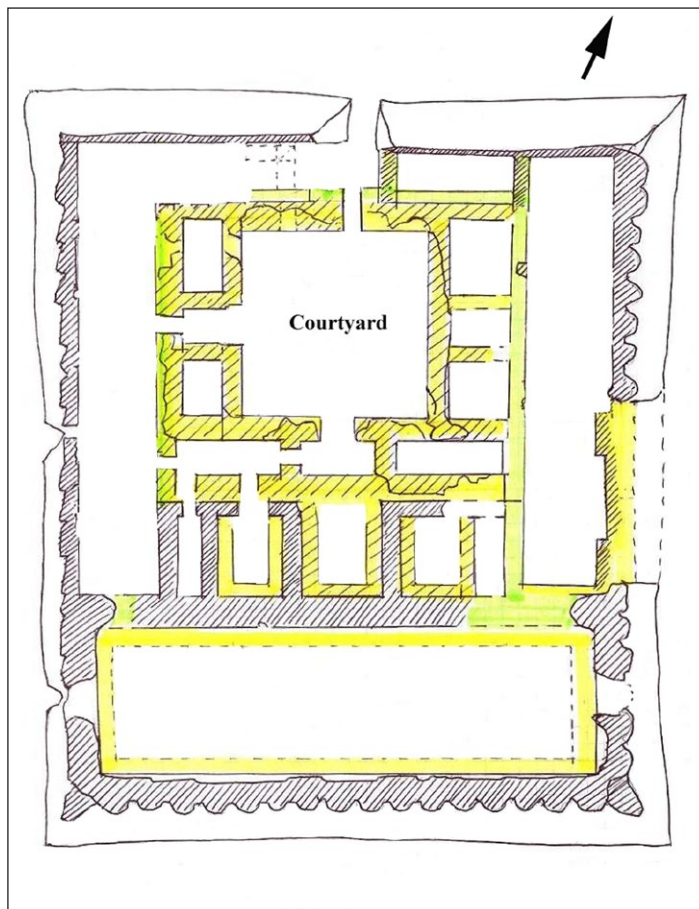
Figure 8: Sketch plan of lower storey, with courtyard surrounded by vaulted spaces. Hatched walls observed. Unhatched conjectured. Not to scale (original drawing by Rejep Jepbarov, modified by Tim Williams).

A courtyard is surrounded by vaulted spaces (**Figure 8**). The courtyard is connected by a staircase descending from the second-floor level in the northwest corner. The base of these steps gives a good indication of the original courtyard level, although these may have been modified during later reuse of the courtyard. A central well or cistern (not fully

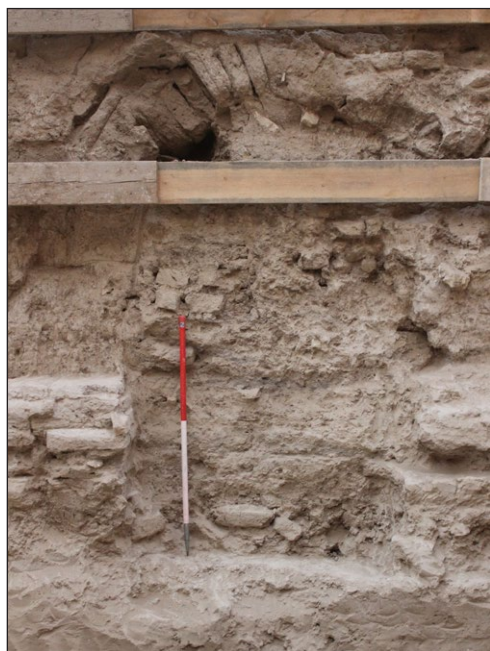
Figure 9: East section of courtyard. Showing arched entrance into eastern vaulted rooms, with several surfaces, rebuilds, modifications, and eventual infilling. (Scale 1 m. Photograph Katie Campbell).

to the courtyard (**Figure 9**), and could have served a range of domestic functions.

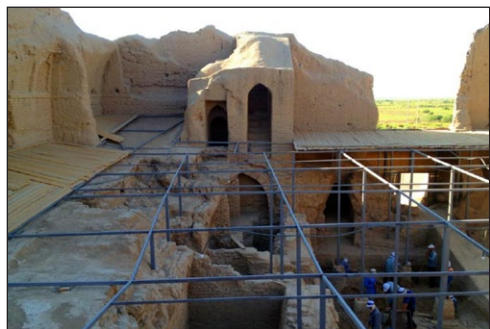
Figure 10: The supporting arch of the ground floor barrel-vaulted rooms, visible below the staircase (Photograph Rejep Jepbarov).

The courtyard is surrounded by an extensive network of mudbrick barrel-vaulted spaces, which created a platform for the second storey (**Figure 10**). These effectively functioned as a crypto-portico, well known in classical, Late Antique and Islamic contexts, designed to provide a stable platform for the main building level without requiring massive retaining walls and huge volumes of earthen platform. The technique is seen elsewhere; for example, at Qal'a-yi Ramūk (Kerman Province, Iran), with a similar arrangement

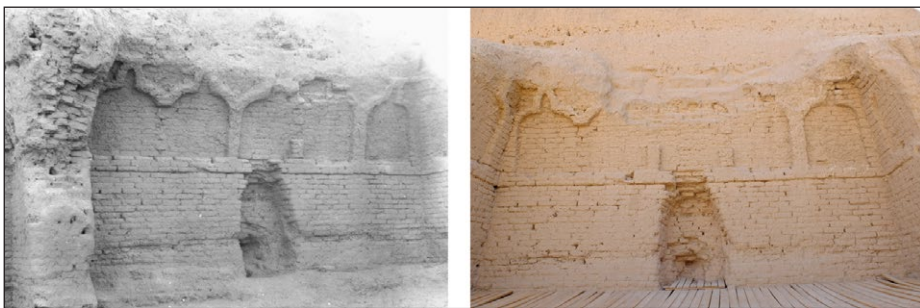
Figure 12: Decorative patterns on the eastern side of Room 4. Comparison with the 1924 Cohn-Wiener photograph (left) (Cohn-Wiener Archive), shows that the second and third decorations have almost disappeared within the last century (right – in 2017) (Photograph Sébastien Moriset).

while varying in size north-south. Room 1 has traces of a barrel-vaulted roof and an area of square mudbrick flooring survived, with a doorway in the north wall, connecting to Room 2. Elsewhere in this range, due to erosion, no floors survived. Rooms 2 and 3 were domed, with squinches supporting a series of concentric arches. Rooms 4 and 5 were roofed with tall vaults, rising from brick string courses (Herrmann 1999: 84–5). A floor to ceiling height of c. 5.6 m has been conjectured for the large rectangular Room 4, which had a panel of appliqué decoration (a series of blind arches), with a niche below (**Figure 12**).

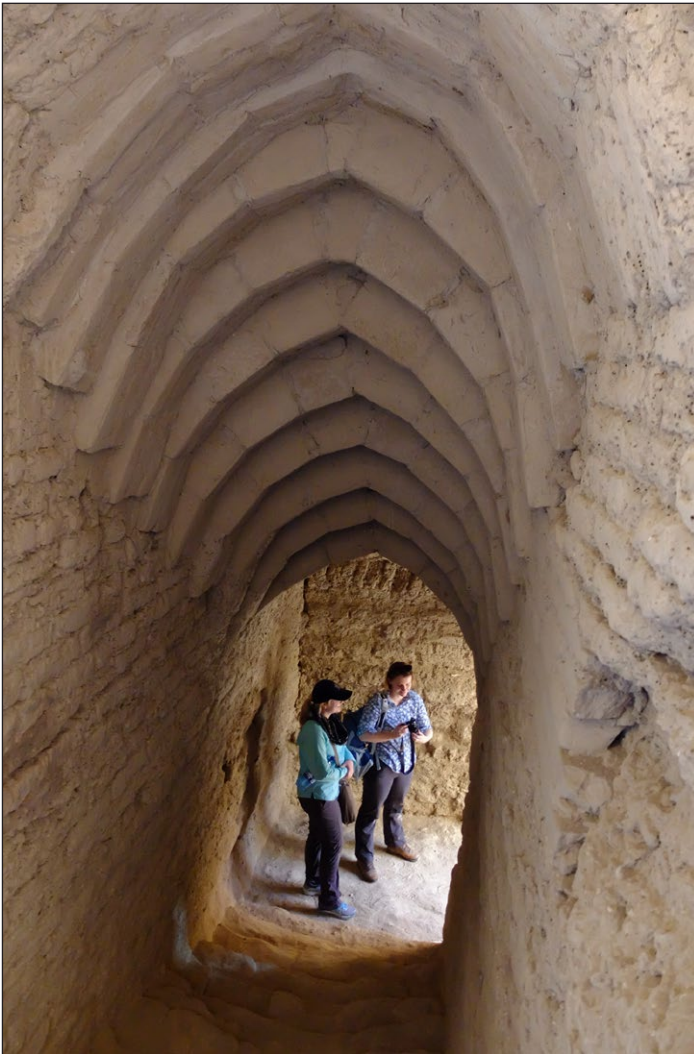
Figure 13: Internal staircase, roofed by a series of stepped tunnel vaults, leading down from second storey to the courtyard (Photograph Sébastien Moriset).

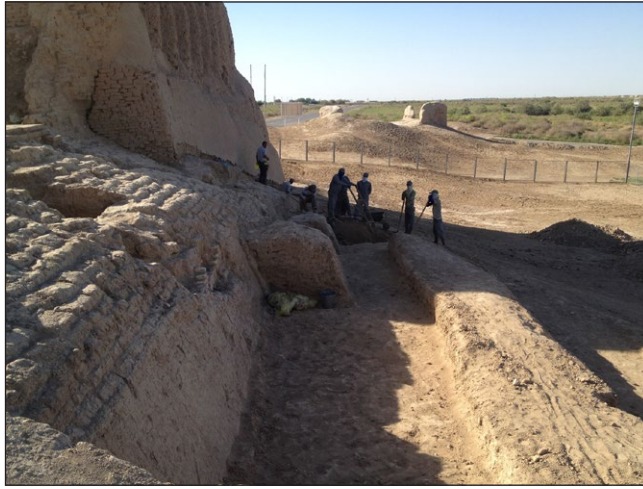
Figure 14: Eastern side of the Great Kyz Kala looking north, during excavation by the Park. Note the fair face to the skirt/glacis (to the left), and the buttresses constructed along the northern part of the façade (centre). The decreasing height of the buttress/pillars to the north reflects erosion patterns, rather than necessarily reflecting their original size. To the right the long wall parallel with the façade is just beginning to be cleaned (Photograph Paul Wordsworth).

The complex was constructed on a solid platform of earth, c. 2 m in height. The interior of the platform appears to have been largely composed of rammed earth, although the excavations have thus far not penetrated the platform to any significant depth (**Figure 4**). The external face of the platform was constructed of mudbrick, tiered near the top and then sloped with a fair face, to form a glacis or skirt, extending some 2m from the base of the exterior wall (**Figure 14**).

- Along the northern part of eastern façade, four mudbrick pillars have been uncovered, extending from the area of the suggested entrance to the north (**Figure 14**).⁶

- Along the entire length of the eastern façade, some 2m to the east of the base of the skirt, lay a long mudbrick wall running parallel with the façade (**Figure 14**); this again suggests considerable attention along this façade. Perhaps the wall and the pillars supported a timber ramp running along the wall from the north.

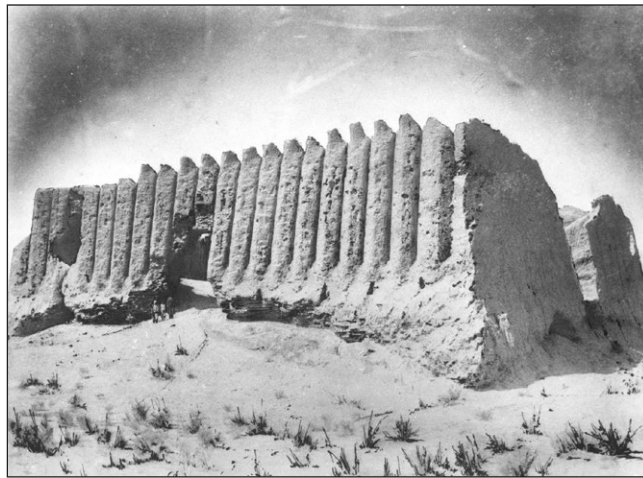
Figure 15: Greater Kyz Kala from north-east in 1890 (Zhukovskii 1894: figure 25).

In the **East wall**, a large section of the façade has collapsed, alongside Room 13, although the earliest image (**Figure 15**) shows that only part of two corrugations are missing. Several structural features might suggest this is a more likely entrance:

Valentin Zhukovskii's superb images from 1890 (Zhukovskii 1894: **Figure 25**) (**Figure 15**), indicate that there was insufficient space to enable direct second floor access at this point. However, a lower entrance, at the level of the skirt, or within the skirt, with internal steps within Room 13, would be quite possible. Unfortunately, this area is badly damaged by the later collapse and erosion, and the identification, while suggestive, is not conclusive.

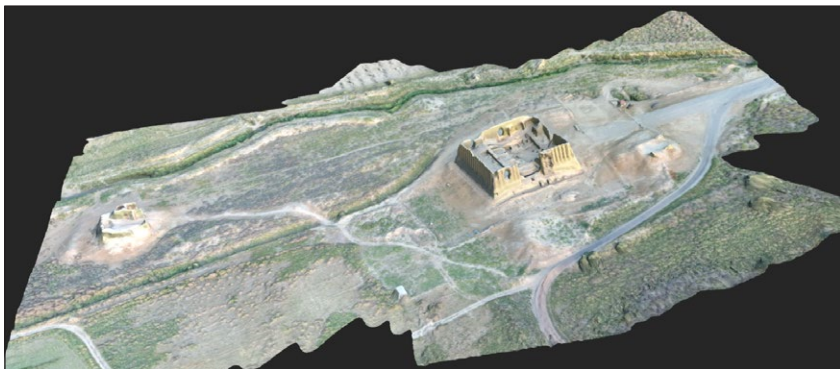
Figure 16: Model from UAV images (looking west), showing complexity of landscape features around the Kyz Kala, including modern canals the west of the complex (Image constructed by Gai Jorayev).

gardens. Pugachenkova, for example, suggested this for Munon Tepe (Pugachenkova 1958: 159). Recent work analysing satellite/UAV images (**Figure 16**) and excavations suggest that the Great Kyz Kala lay within a walled enclosure. The wall, some 2 m thick, with interval towers c 3.2 m in diameter, has been uncovered some 6m from the monuments skirt along the northwest side. It is currently not clear where the boundary lay on the other sides. A substantial mound some 25 m to the north-east of the monument, and a large mound 18 m to the east (**Figure 16**), indicate other structures in close proximity and perhaps associated with the complex, while the Lesser Kyz Kala complex lies some 140 m to the south.

The landscape to the west of the monuments has been more intensively farmed in the 20th century, and modern irrigation works, including new canals (see **Figure 16**), make it more difficult to interpret the ancient landscape. A major canal, the Khormuzfarra, is thought to have run south to north through the area, and a very approximate line would suggest that it ran immediately to the west of the Great Kyz Kala complex (see **Figure 2**) (Williams In Press). It is probable that the canal would have been a major factor in the siting of the complex, enabling good access to clean water, and it is tempting to suggest that gardens and water features provided a verdant surrounding to the main monument. A future programme

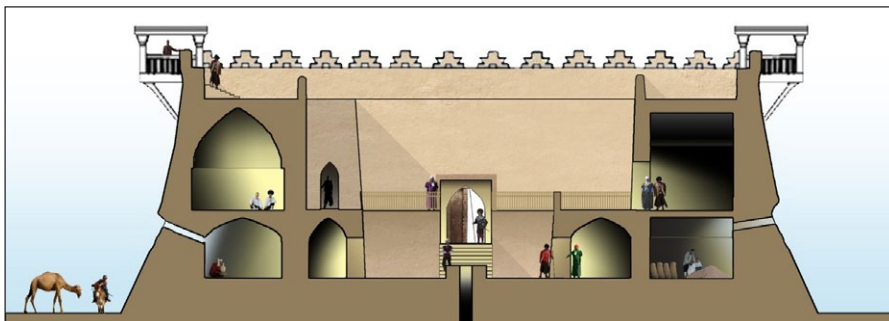
Figure 17: An imaginative reconstructed cross-section of the Great Kyz Kala (Illustration by Sébastien Moriset).

While the lower storey of the Great Kyz Kala was clearly a functional space, with the well in the courtyard and the vaulted rooms perhaps used for storage and domestic functions, the upper storey was a more palatial space, with a series of impressive rooms providing reception/formal spaces, bed chambers, etc. ranged around the galleried central light-well (**Figure 17**).

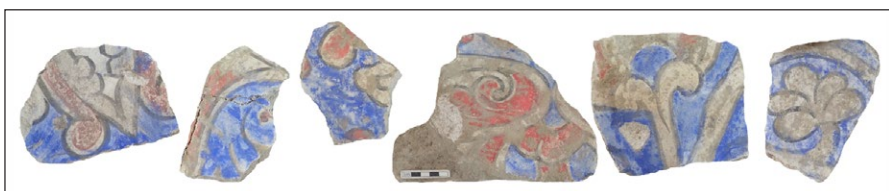
Figure 18: Painted plaster, probably from the collapsed upper floor for the Great Kyz Kala (Scale 5 cms) (Photographs by Paul Wordsworth).

Many of the second storey rooms had some architectural/decorative sophistication. Painted plaster (**Figure 18**), for example, has been discovered in the collapsed debris and probably came from rooms on this level, and the applique decorations in Room 4 suggest a well-appointed space of some status.
