## Forgotten buildings: detached kitchens in Southeast England

David Martin

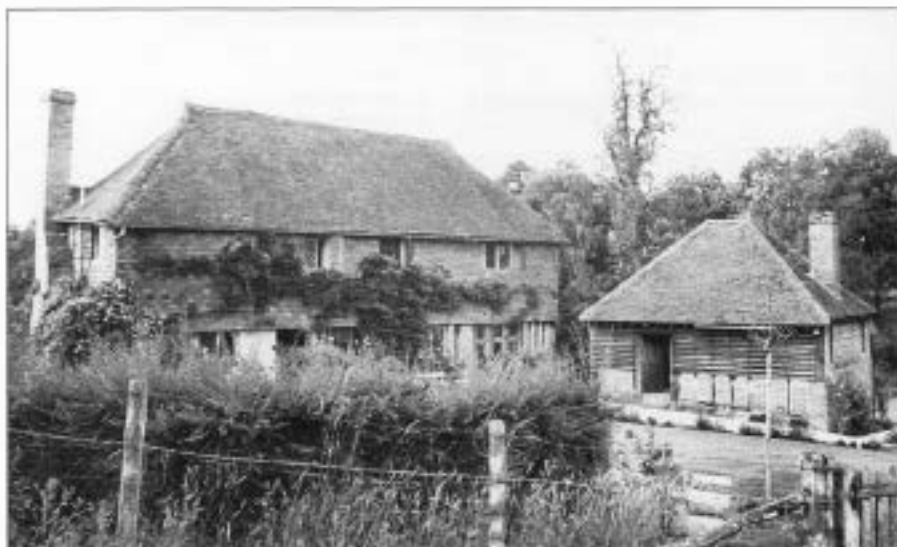
Figure 1 The detached kitchen (right) at Littlebrook (Crowborough, Sussex) in 1973.

Although the documents suggest that vernacular detached kitchens were once common, very few of them appear to have survived. However, the total is gradually increasing as more buildings are recognized for what they are. One example at Littlebrook (Crowborough, Sussex) exists today as a freestanding “shed” in front of the house (Fig. 1), but usually those that remain have either been incorporated into the expanded main house or have been demoted to agricultural use.

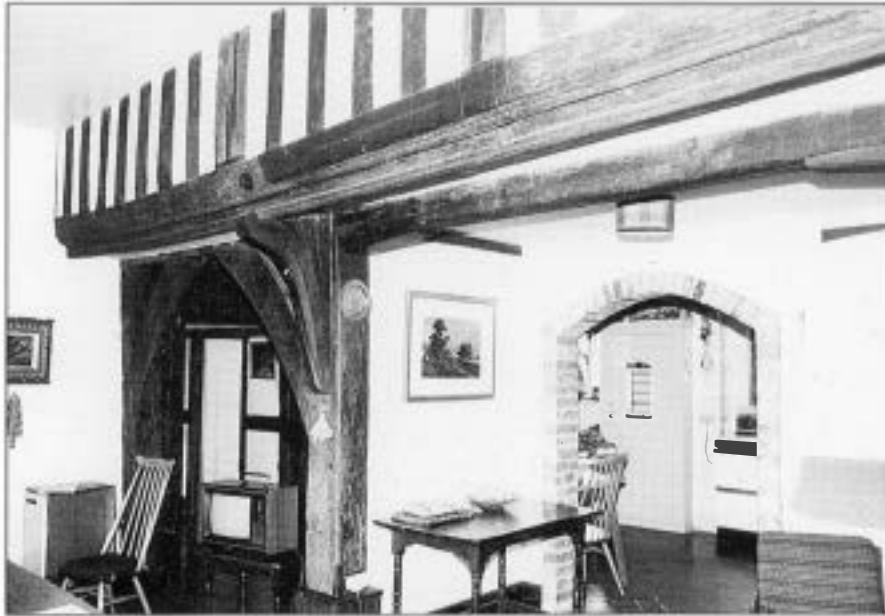
**Figure 4** The original southern external wall (upper left) of the kitchen at Comphurst, now visible within a later addition. The ground-floor section of the external wall has been removed, but mortices in the remaining timbers provide evidence of its design.

ground-floor room with a small first-floor chamber built over one end. With the exception of Littlebrook, all have at least one, and usually two, upper chambers. Research suggests that a typical arrangement was a building in which a two-bay "kitchen" room had one bay open to the roof, with a first-floor chamber over the second bay. In addition, there was a further ground-floor room (in some instances more than one) with a chamber above. In some buildings a gallery ran across the open bay linking the chambers (Fig. 2). Other variations occur. At Comphurst, (Wartling, Sussex) the cooking room is located at the end with only a narrow area, called a "smoke bay", open to the roof. Externally this example is particularly elaborate, with an overhanging upper storey, moulded beams and costly wall framing, although internally it is very plain (Figs 3, 4).

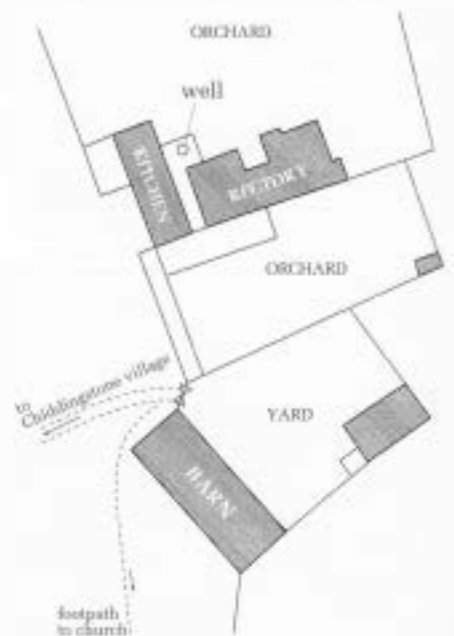
**Figure 6** The buildings at the Old Rectory, Chiddingstone, Kent, in 1706 showing the relationship of the kitchen (which was approximately 15 m (49 feet) long) to the house; based upon a plan held at the Centre for Kentish Studies (see n. 4), reference U909, P9.
