RESEARCH ARTICLE

In-situ measurements of wall moisture in a historic building in response to the installation of an impermeable floor

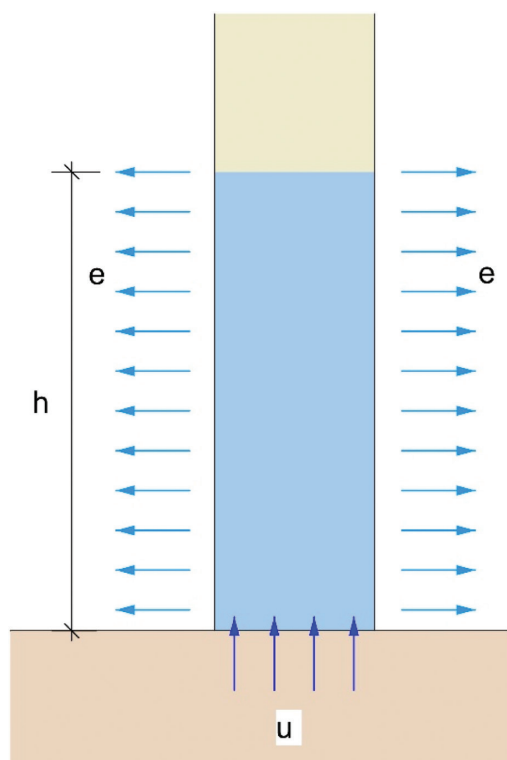
Figure 1

A conceptual model of wall damp rise by Hall and Hoff [7], with soil moisture uptake (u) and wall evaporation (e) driving the saturated wall height (h), in a wall thickness (b).

Water transport in buildings and building materials is site-specific and complex, but is generally dominated by capillary forces and unsaturated flow within the pores of building materials [2,5,6]. It can be difficult to model unsaturated flow through historic masonry walls because it is not always possible to intrusively characterise the physical properties of the wall materials, their heterogeneity and the interfaces between the different materials forming the wall. However, it is possible to measure and model the primary processes influencing the supply and removal of water within walls, to consider the behaviour of the wall as a system. Hall and Hoff [7] developed a quantitative representation of the primary processes controlling moisture migration and wall damp rise in a masonry wall (Fig. 1). This shows that ground moisture (u) is absorbed at the base of a homogenous, porous wall of thickness b . To ensure the conservation of mass, a state of dynamic equilibrium is established if the height of the wetted part of the wall (h) varies in response to the evaporation rate on the wall surface (e).

The Hall and Hoff [7] conceptual model describes the primary process of moisture migration through porous building materials. However, the wall moisture dynamics in a historic building is further complicated by in situ conditions that are difficult to quantify, measure and model. This includes but is not limited to (i) the heterogeneous nature of old masonry walls, and (ii) the moisture storage and conductivity properties of the materials forming the wall. Therefore, in situ monitoring was identified as the most effective method to measure the response of a masonry wall to the installation of an impermeable floor barrier in a historic building.

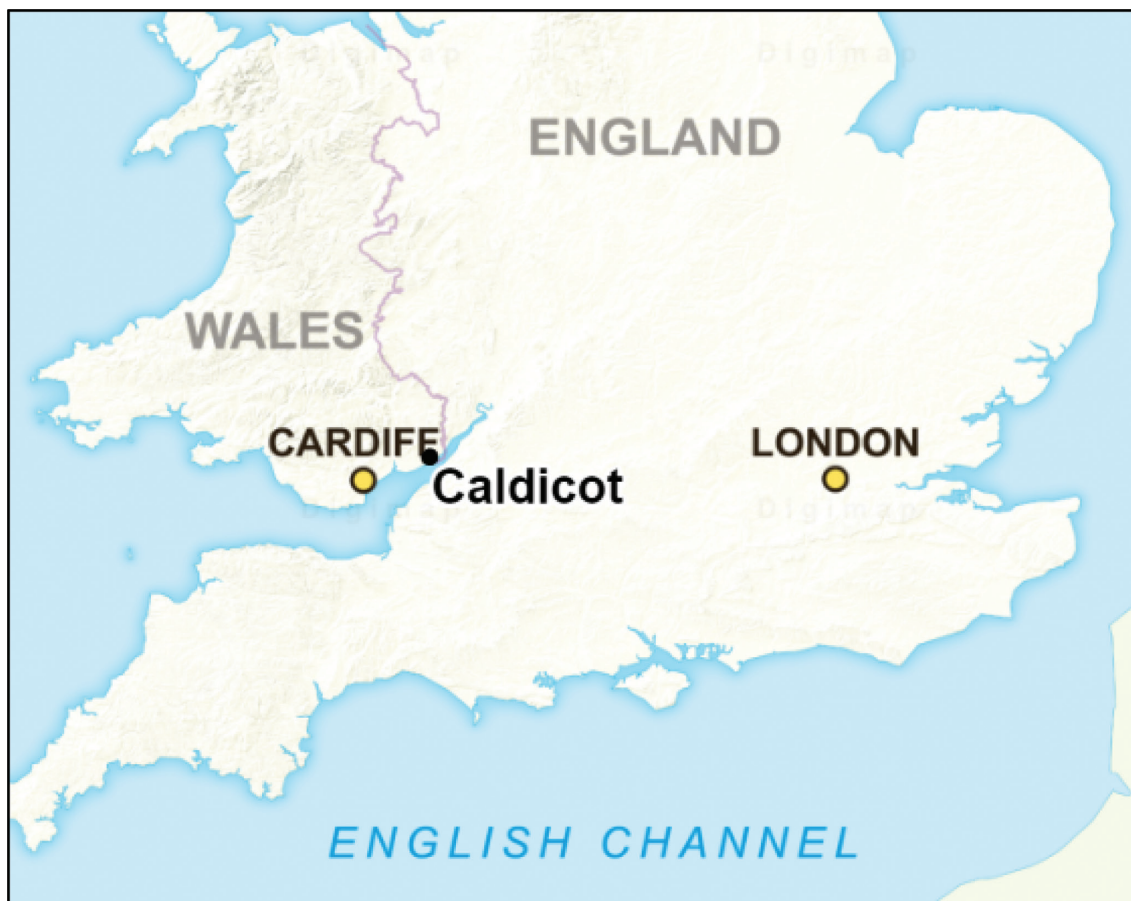
Figure 2

Court House is located in Caldicot, Wales. © Crown copyright and database rights 2021 Ordnance Survey (100025252) using Digimap Ordnance Survey Collection, <https://digimap.edina.ac.uk/>.

A 3-year monitoring programme was undertaken to measure moisture levels in a 600 mm thick, composite rubble-core masonry wall at Court House; a private residential property in Caldicot, Wales (Fig. 2). Court House is a Grade II listed building originating from the 16th or 17th Century [8]. The masonry wall was located on the north elevation of the house and formed the external wall of an unheated, flagstone-floored room that was used as a pantry during the monitoring period (Fig. 3).

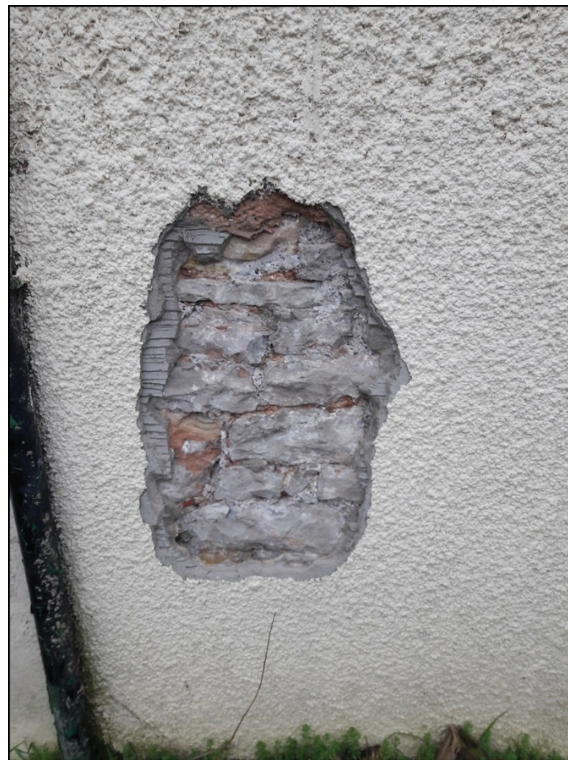
Figure 3

The external face of the pantry wall at Court House.

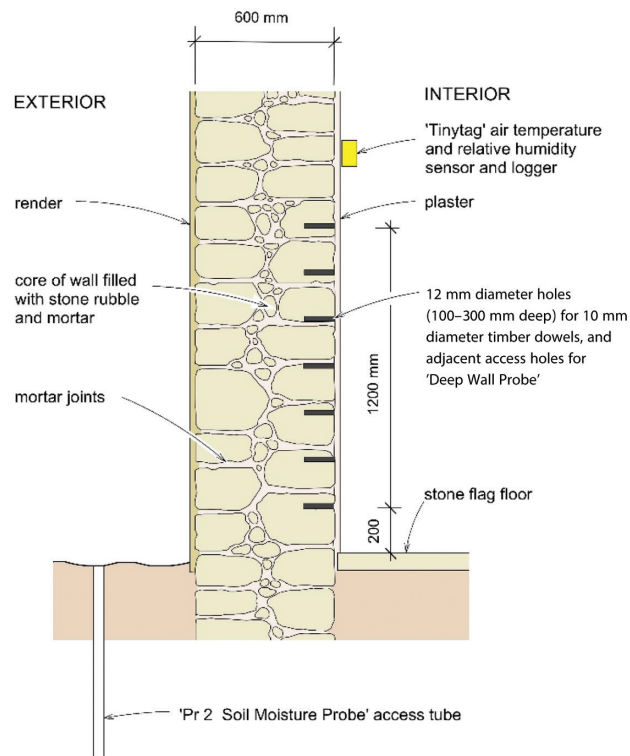
Instrumentation installed in a 600 mm thick, rubble-core masonry wall at Courth House to measure wall moisture (%), soil moisture (%) and evaporative drying on the wall face.

The monitoring programme included measurements of soil moisture levels at the base of the wall, the evaporative drying on the wall faces and the moisture levels within the wall (Fig. 4), in accordance with the conceptual model (Fig. 1). Details of the electronic sensors are shown in Table 1.

Figure 4 shows the layout of instrumentation installed at Court House. Evaporative conditions on the internal and external wall faces were continually measured and logged. Externally, a WS-GP1 weather station [11] was installed to measure hourly changes in solar radiation (kWm^{-2}), air temperature ($^{\circ}\text{C}$), humidity (%), rainfall (mm/tip), wind speed (ms^{-1}) and wind direction ($^{\circ}$). A Tinytag Plus 2 datalogger [12] was installed at the top of the internal wall face to measure hourly changes in air temperature ($^{\circ}\text{C}$) and relative humidity (%) directly adjacent to the wall surface.

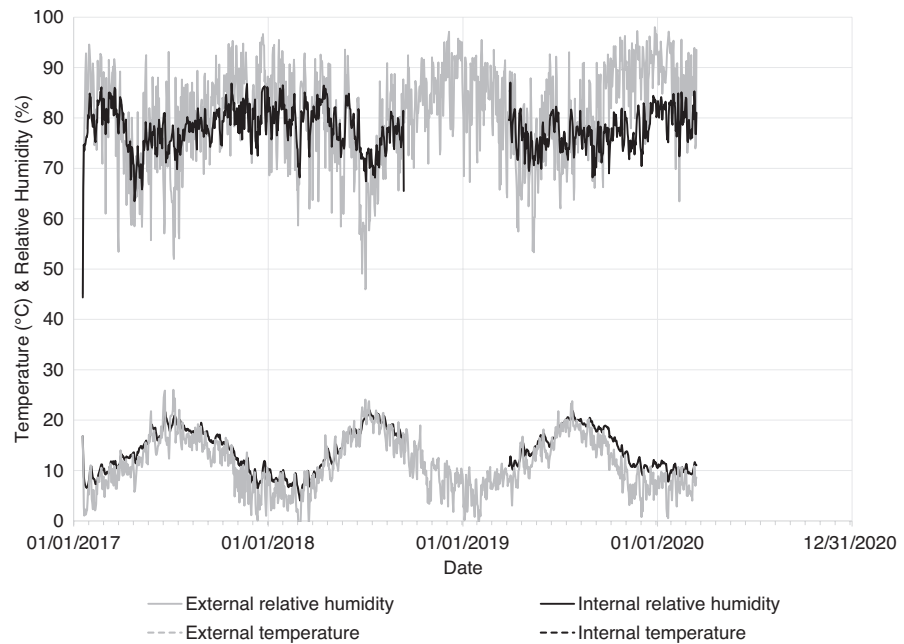
Daily average temperature ($^{\circ}\text{C}$) and relative humidity (%) measured internally (Tinytag logger data) and externally (weather station data) at Court House between 2017 and 2020. Note that internal Tinytag data are missing from September 2018 to March 2019 due to instrument damage.

The internal and external temperature ($^{\circ}\text{C}$) and relative humidity (%) data showed potential evaporative drying during the summer months, followed by reduced drying through the winter months. These seasonal changes are typical of the temperate UK climate [23,24]. Figure 5 shows increased temperature and reduced relative humidity in the summer months (April to September), relative to the cooler, more humid winter months (October to March). A comparison of annual cumulative potential evapotranspiration (PET , mm) and rainfall (mm) shows that PET was greatest in the summer months and least in the winter months, with consistent total, annual cumulative PET (Fig. 6). The calculated cumulative potential evapotranspiration was higher than comparative measurements in southern England [25,26], due to the simple PET model used (Equation 2). Figure 6 shows that 2018 was both wetter (January to June) and drier (July to December) than in 2017 and 2019. According to the conceptual model of wall damp rise (Fig. 1) and Equation 5, these evaporative conditions would lead to greater annual variation in the wall damp rise (mm) in 2018 than in the preceding or succeeding years (2017 and 2019).

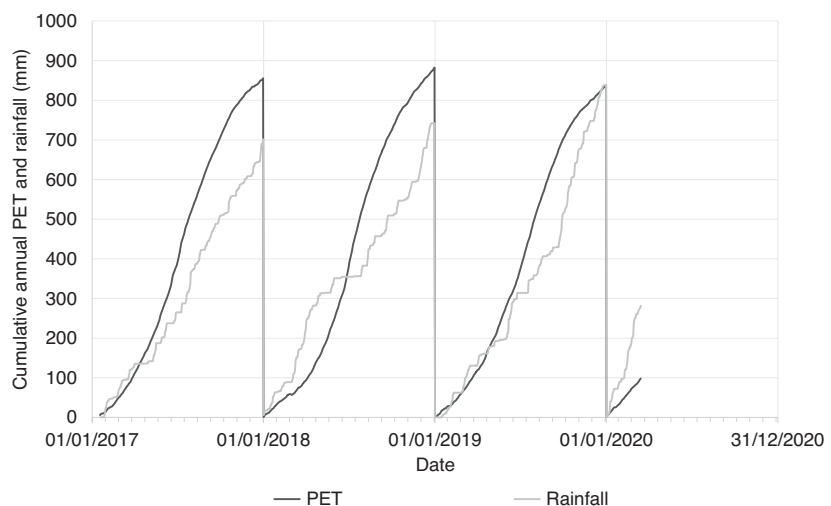
Figure 6

Cumulative annual evapotranspiration (ET_0 , mm) and rainfall (mm) measured by the weather station at Court House. Note that the measurements start on 18/01/2017.

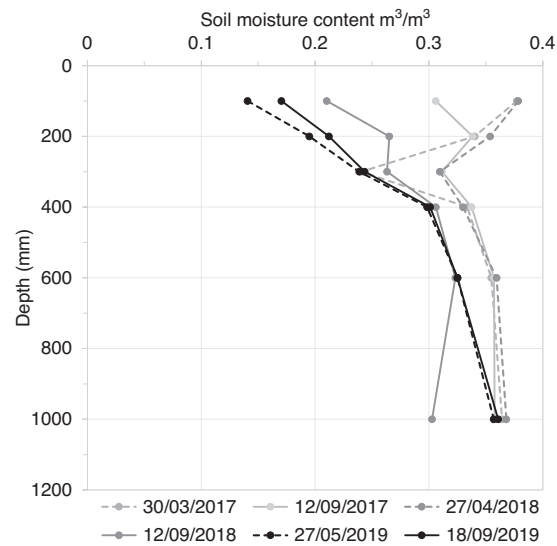
Soil moisture content profiles measured at the end of winter (April/May) and the end of summer (July/September) at Court House.

Figure 7 shows soil moisture content profiles measured at the end of winter and the end of summer between 2017 and 2019. The greatest variation in soil moisture content occurred in the

near surface, up to 0.4 m below ground level, as is typical in clay soils with grass vegetation at equivalent latitude [18]. Figure 7 shows that the soil moisture content was often below field capacity ($\theta_{FC} = 38\%$) and that a supply of water was not consistently available at the base of the masonry wall. Figure 8 shows that soil moisture was available at the base of the masonry wall during the winter months (i.e., SMD = 0), while there was a soil moisture deficit (i.e., SMD > 0) during the summer months. This shows that the availability of soil moisture varied seasonally and was not constant, as was assumed in the conceptual model (Fig. 1).

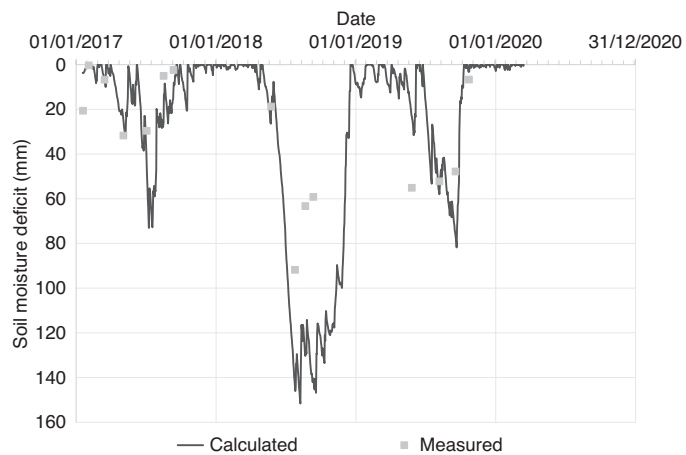
Figure 8

SMD (mm) at Court House (i) calculated using daily weather station data and (ii) measured using a PR2 soil moisture probe (up to 1 m below ground level).

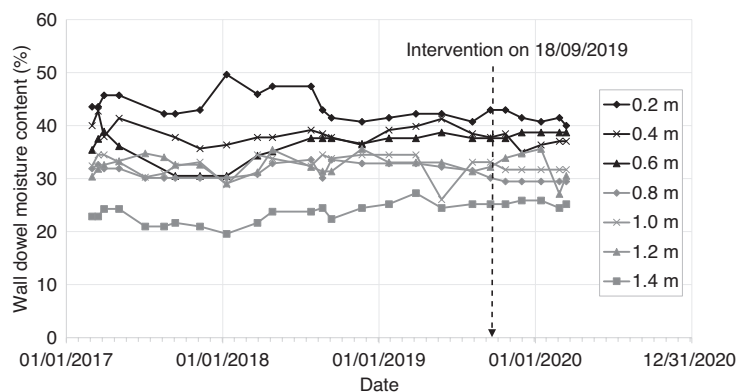
Measurements of timber dowel moisture content (by mass) between 0.2 m and 1.4 m above ground level over a 3-year period between 2017 and 2020, including an intervention to seal the floor on 18/09/2019.

Figure 9 shows the dowel moisture (mass) content values taken at approximately monthly intervals between March 2017 and March 2020. The measurements show that the dowel was close to 50% moisture content at the base of the wall and consistently greater than higher up the wall. The data

show that the moisture level of the dowels, and by implication the wall, did not vary in response to seasonal evaporation rates. Nor did the dowel moisture levels immediately increase in response to the sealing of the flagstone floor. Measurements with a Tinytag logger (not shown in Fig. 4) showed that moisture levels rapidly increased beneath the vapour-proof barrier within 2 days of installation in September 2019, showing ground moisture transfer through the floor and into the internal environment of the room.

was confirmed by the measurements showing that the wall moisture levels did not vary seasonally, nor did they vary in response to the installation of a vapour-proof barrier to seal the floor (Fig. 9).

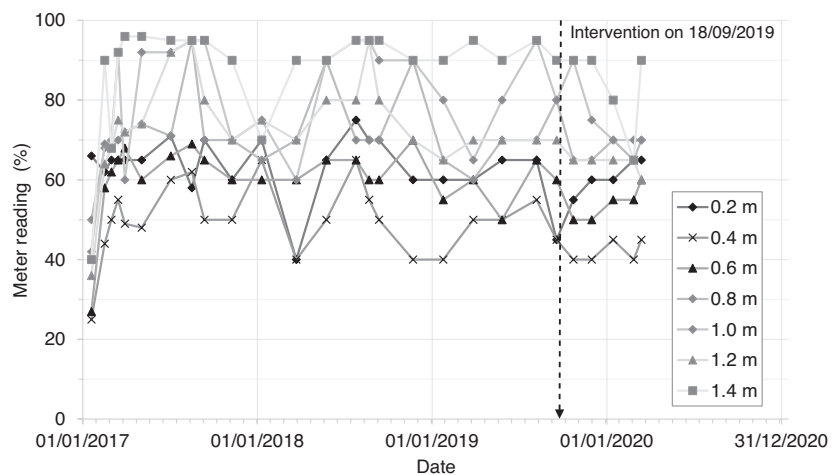
Protimeter Mini Moisture Meter readings measured between 0.2 m and 1.4 m above ground level over a 3-year period between 2017 and 2020, including an intervention to seal the floor on 18/09/2019.

Figure 10 shows the wall moisture levels measured using the moisture meter with a deep wall probe. The wall moisture probe showed consistently lower meter readings at the base of the wall relative to the upper part of the wall. The meter readings were erratic and did not show a temporal trend. It is possible that the meter readings were responding to changes in the internal air temperature and humidity or were influenced by the distribution of salts within the wall [27]. They were not considered to be reliable measurements of wall moisture levels for this study.

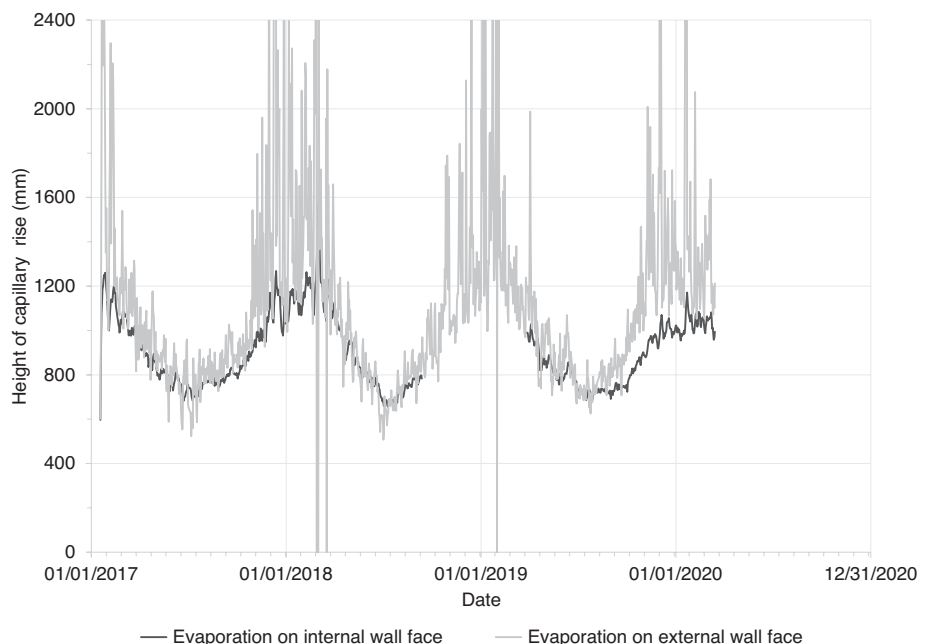
The height of wall capillary rise calculated using the Hall and Hoff [7] sharp front model using PET derived from temperature and relative humidity data measured (i) on the internal wall face and (ii) on the external wall face. Note: Internal wall face data are missing for September 2018 to March 2019. Extreme capillary rise values for the external wall face have been omitted for clarity.

Figure 11 shows the height of wall capillary rise calculated using the Hall and Hoff [7] sharp front model, assuming (i) the supply of water at the base of the wall (ii) potential evaporative drying measured on the internal and external wall faces at Court House and (iii) a porous masonry wall with interconnected pores and without finishes. This shows that prior to the installation of the vapour-proof barrier, given the model assumptions, the capillary rise should have varied between 800 mm (summer) and 1200 mm (winter) above ground level. However, the historic masonry wall was not subject to capillary rise, despite the supply of water at the wall base (Fig. 8) and seasonally variable evaporative drying on the wall face (Fig. 6). Inspection of the wall showed that the wall was formed from porous materials, but with large voids and discontinuities that would inhibit capillary flow. Therefore, the fabric of the wall itself did not facilitate water being ‘driven up’ by capillary action. This
