**Article title:** Hygrothermal Monitoring of Replacement Infill Panels for Historic Timber-Frame Buildings: Initial Findings

# Hygrothermal Monitoring of Replacement Infill Panels for Historic Timber-Frame Buildings: Initial Findings

## Abstract

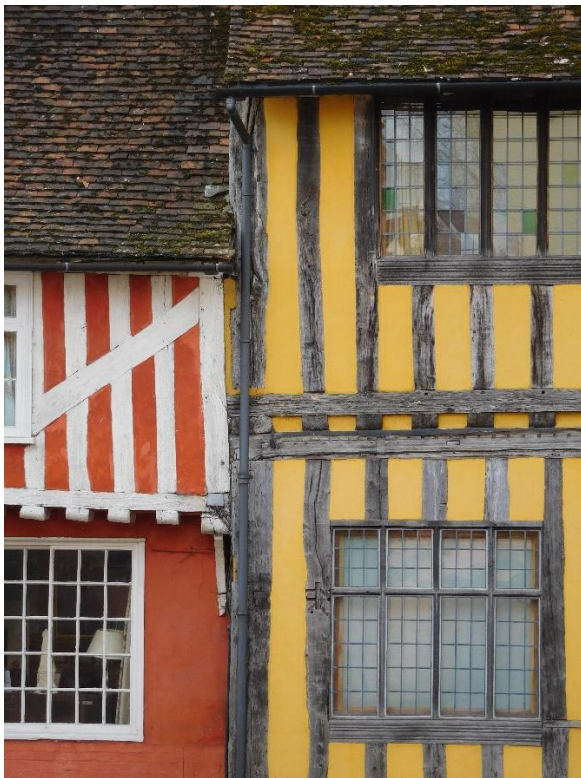
Figure 1. C15th timber framing, The Manor House (left) and 53 Church Street (right), Lavenham, Suffolk. Source: (Whitman, 2017)

Traditional timber-framed buildings in the UK (Figure 1) are most commonly constructed from oak, with some examples also found in elm and other native hardwoods (Rackham 2003). The timbers form a framework, which is then infilled in a variety of materials, these varying depending on the age and geographic location of the building (Figure 2).

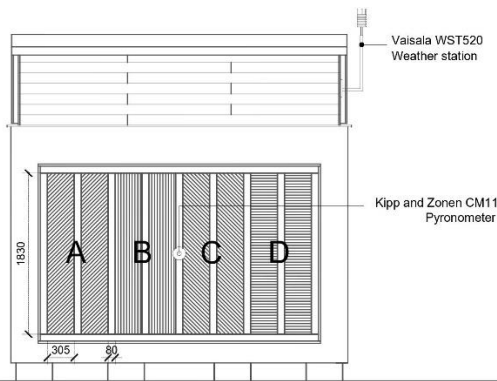
Figure 3. North elevation of test cell showing pairs of panels. Source: (Author's own, 2017)

A test cell with [a controlled internal environment](#) (internal dimensions 3.5m [wide](#) x 1.9m [deep](#) x 2.2m [high](#) ([width x depth x height](#))) was constructed at Cardiff University. ~~to create a controlled internal environment, of which the~~ test panels form the [external envelope of the northern façade wall of the cell and, their outer face are](#) exposed [externally](#) to the Cardiff climate. The dimensions of the test panels were determined using the results of a study of a representative sample of 100 historic timber-framed buildings with exposed timber frames (Whitman 2017). This showed 53% to be square framed (of approximately equal width and height) and 47% close studded (tall thin panels). The average size of the square panels was 785mm x 950mm (width x height) and the close studded 305mm x 1830mm (width x height), approximately 1-~~foot~~ wide by 6-~~foot~~ tall. Given the configuration of the test cell, it was decided to construct close studded panels, allowing the monitoring of eight adjacent panels all at the same height above ground level (Figure 3). [This array of eight panels were](#) ~~was~~ [constructed using reclaimed oak, and allowed for the monitoring of pairs of panels of four different infill solutions](#) (Figure 4).

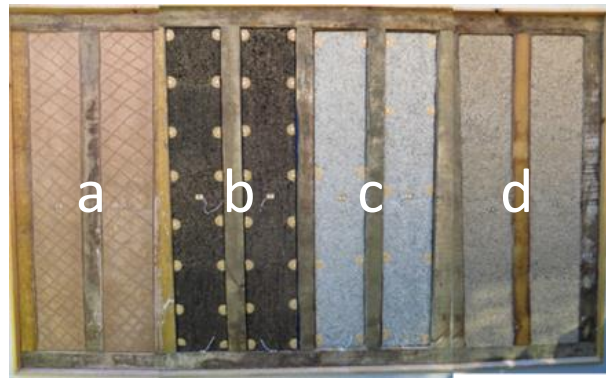
Figure 4. Photograph of panels prior to rendering (Whitman, 2019)

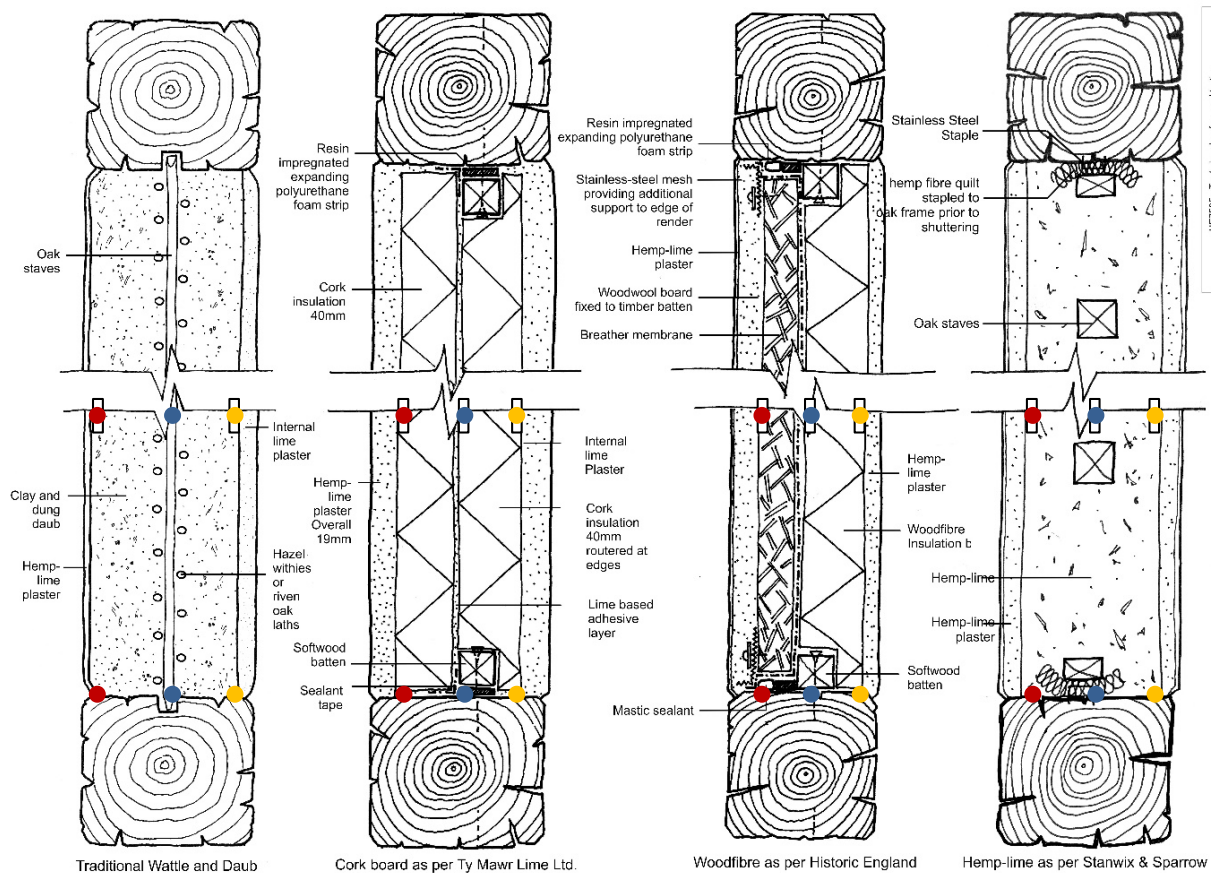
Figure 1. Sections showing panel infill details and monitoring locations. Red- external I, Blue- central I, and yellow- Internal (i). Source: (Author's own based on (McCaig and Ridout 2012; Stanwix and Sparrow 2014))

~~This array of eight panels were constructed using reclaimed oak, and allowed for the monitoring of pairs of panels of four different infill solutions (Figure 4). These~~ The infill solutions were, the three previously studied solutions, a) wattle & daub; b) expanded cork board; c) composite wood wool and wood fibre; in addition to d) hempcrete, a construction technique originally developed in France in the 1980s specifically for the retrofit of historic timber-framed buildings (Stanwix and Sparrow 2014) and recommended for such work in a number of publications (McCaig and Ridout 2012; Suhr and Hunt 2013). Details of the infill solutions are shown in Figure 5.

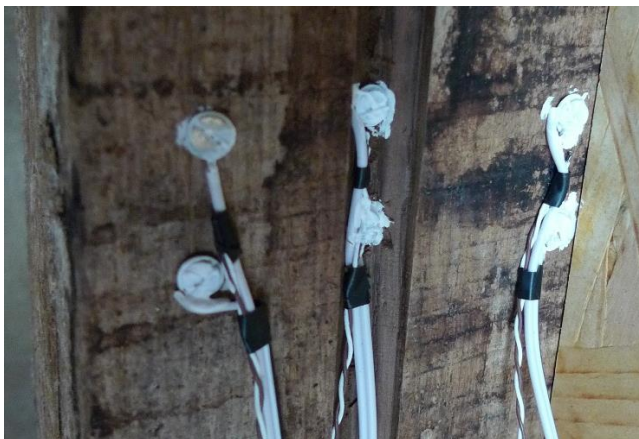
*Figure 6. Pairs of stainless-steel screws embedded directly into the timber frame. The electrical resistance between the two is measured and used to calculate moisture content of the timber.*

Type T thermocouples were used to measure temperature (°C). Following a literature review (Phillipson et al. 2007; Pinchin 2008; Viles et al. 2015; Viles et al. 2017,2018), electrical resistance was chosen as the measurement methodology for moisture content (%). This allowed continual measurement with minimal impact on the surrounding materials. A methodology based on the wood block/dowel methodology used by Dr Paul Baker at New Bolsover (Baker and Rhee-Duverne 2015) and reported in Historic England Research Report 43-2016 (Ridout 2018) was followed. Pairs of stainless-steel screws were embedded at the monitoring points, set 20mm apart along the grain. For monitoring points occurring at the junction between infill panel and timber frame, these were embedded directly into the oak frame (Figure 6). For monitoring points within the depth of the panel, they were embedded in lengths of split oak lath (Figure 7).

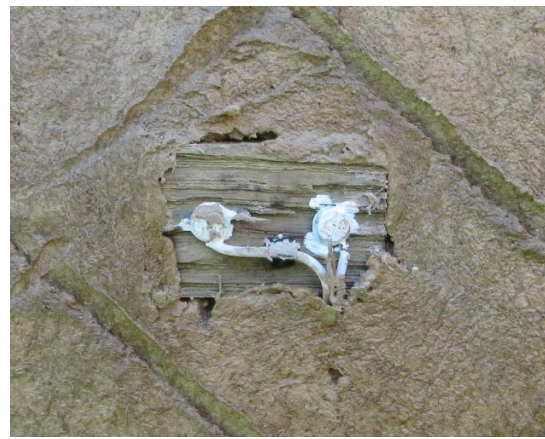
*Figure 7. For points at the interface between materials where no timber exists, the stainless-steel screws were embedded in lengths of split oak lath.*

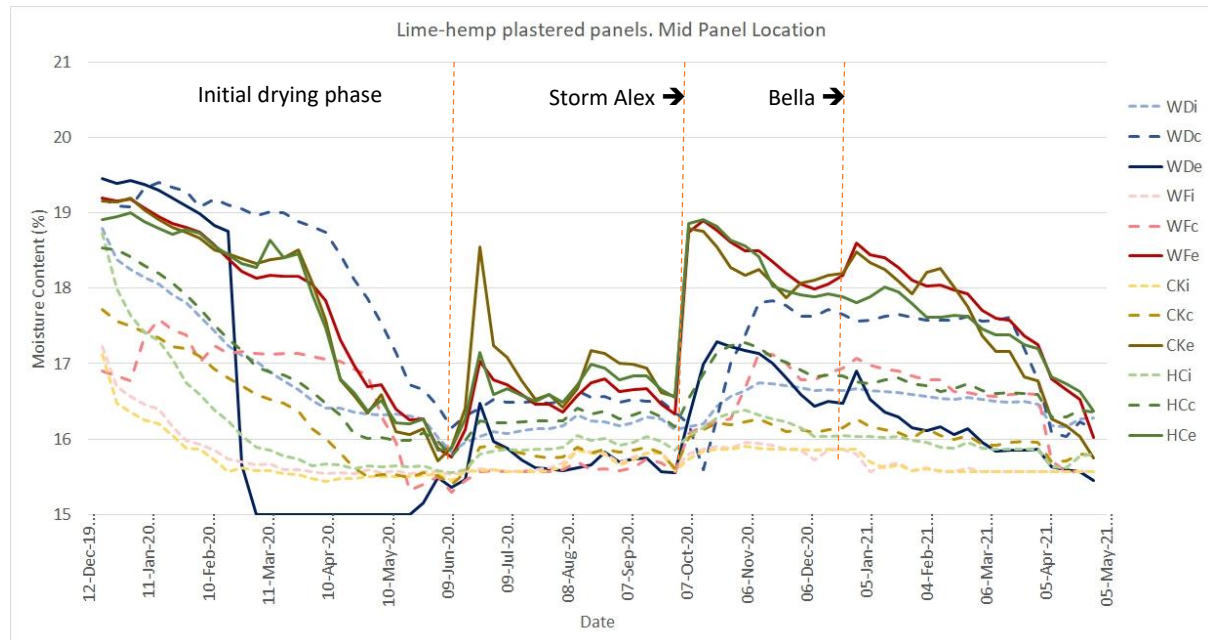
Figure 8. Results for monitoring period 12/12/2019-05/02/2021 for the mid-panel monitoring position for panels finished with Lime Hemp plaster. (WD-Wattle & Daub, WF-Wood Fibre, CK-Cork, HL-Hemp-lime. i-internal, c-centre, e-external.)

The initial results (Figure 8 - Figure 12) show an initial drying period followed by a series of wetting and drying cycles. To date, no evidence of interstitial condensation has been found, with these wetting cycles correlating with climatic measurements of wind-driven rain. The impact of two major storm events, Alex and Bella are particularly prominent. Storm Alex was the event that saw a record-breaking wettest day on record (Met Office 2020). A rapid increase in the moisture content at the interface between the external render and the infill material can be seen in all materials, with the lowest being that of wattle & daub (WDe), for those panels finished in lime-hemp (Figure 8). It would appear that the lower moisture permeability of the other infill materials concentrates the moisture in the external render, whereas the more moisture permeable wattle & daub allows the moisture to penetrate deeper into the panel. A rise in moisture content being measured at the centre of the panel's depth (WDc) and at the interface between the infill and internal plaster (WDi) can be seen to follow ~~with~~ ~~Over time, the~~ ~~of the wattle & daub panel gaining a~~ ~~moisture content~~ ~~at the central~~ ~~position (WDc) becomes~~ higher than the external position (WDe), with this being maintained until the following spring. ~~A similar pattern of behaviour can be seen for the mid-panel positions of the panels finished in NHL 3.5 (Figure 9).~~

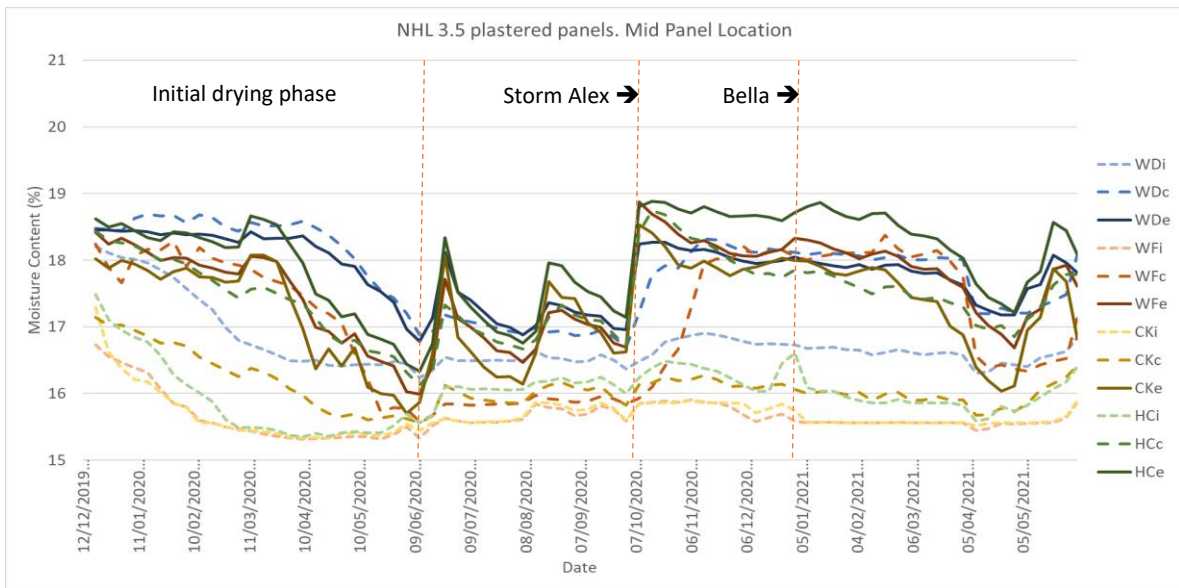
Figure 9. Results for monitoring period 12/12/2019-05/02/2021 for the mid-panel monitoring position for panels finished with NHL 3.5 plaster. (WD-Wattle & Daub, WF-Wood Fibre, CK-Cork, HL-Hemp-lime. i-internal, c-centre, e-external.)

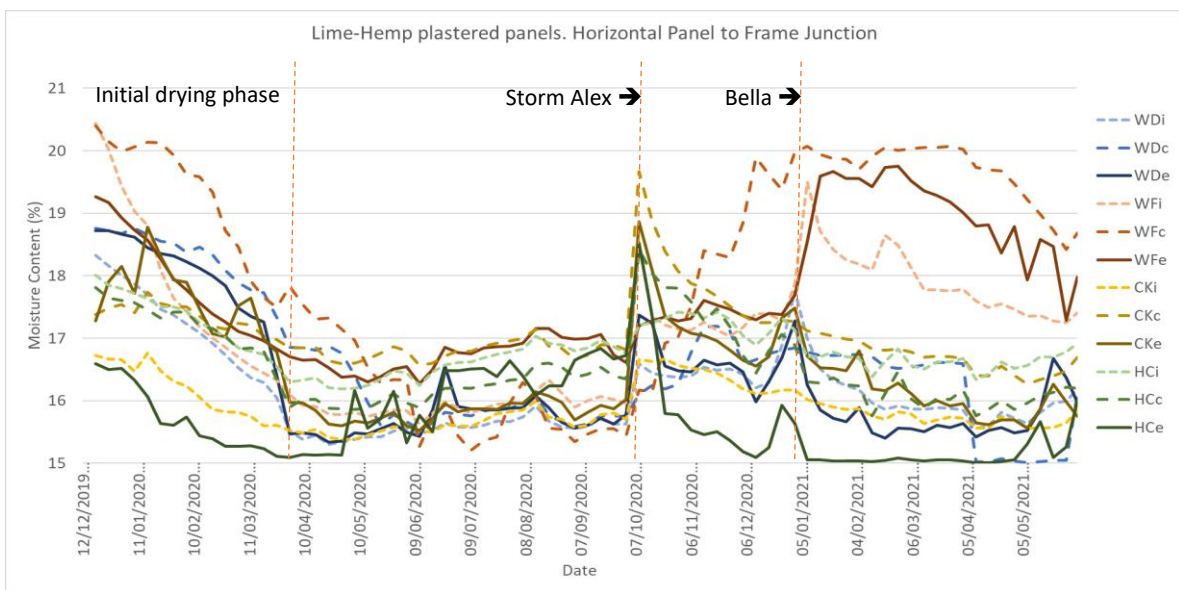
Figure 10. Results for monitoring period 12/12/2019-05/02/2021 for the monitoring position at the horizontal junction between panel and oak frame for panels finished with Lime Hemp plaster. (WD-Wattle & Daub, WF-Wood Fibre, CK-Cork, HL-Hemp-lime. i-internal, c-centre, e-external.)

The results for the monitoring positions located at the junction between the base of the infill panels and the oak frame (Figure 10 and Figure 11) show a reduced initial drying period for those panels finished in lime-hemp plaster. Following the storm induced wetting events, a substantial increase in moisture content is recorded at the centre of the wood wool/wood fibre panel's depth (WFc), and This is followed by an increase at subsequently both the internal (WFi) then the external positions (WFe) following with these continuing to increase which continues for the following months. At the centre the moisture content remains around 20%, or more in the case of the panel finished in NHL 3.5, until the spring. The perimeter detail of this panel includes a bitumen impregnated expanding strip and mastic sealant (McCaig and Ridout 2012) which potentially traps the moisture at this point. This highlights an area for further research and underlines the challenge that this exposed junction presents for both design and workmanship.

The moisture contents at the vertical junction between panel and frame (Figure 12) are overall lower than those for the horizontal junction (Figure 10 and Figure 11), most probably due to gravity permitting drainage down the joint. The highest moisture content is measured at the centre of the expanded cork board's depth. An expanding foam sealant is also used here and similarly may be trapping moisture. Further investigation is needed to compare the use of moisture permeable and non-moisture permeable solutions to this interface.

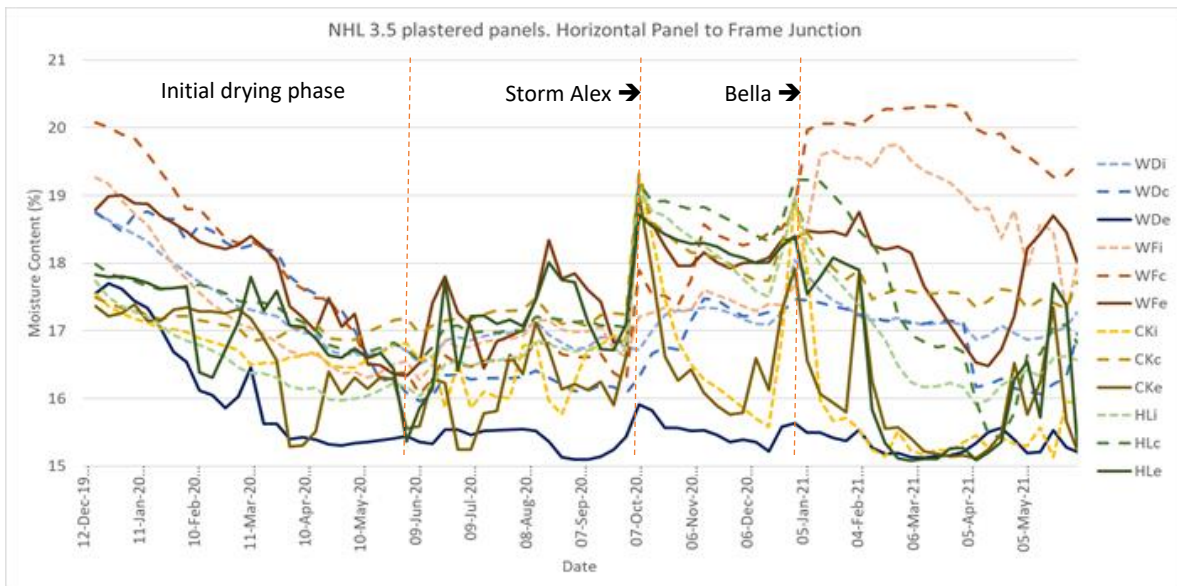
Figure 11. Results for monitoring period 12/12/2019-05/02/2021 for the monitoring position at the horizontal junction between panel and oak frame for panels finished with NHL 3.5 plaster. (WD-Wattle & Daub, WF-Wood Fibre, CK-Cork, HL-Hemp-lime. i-internal, c-centre, e-external.)

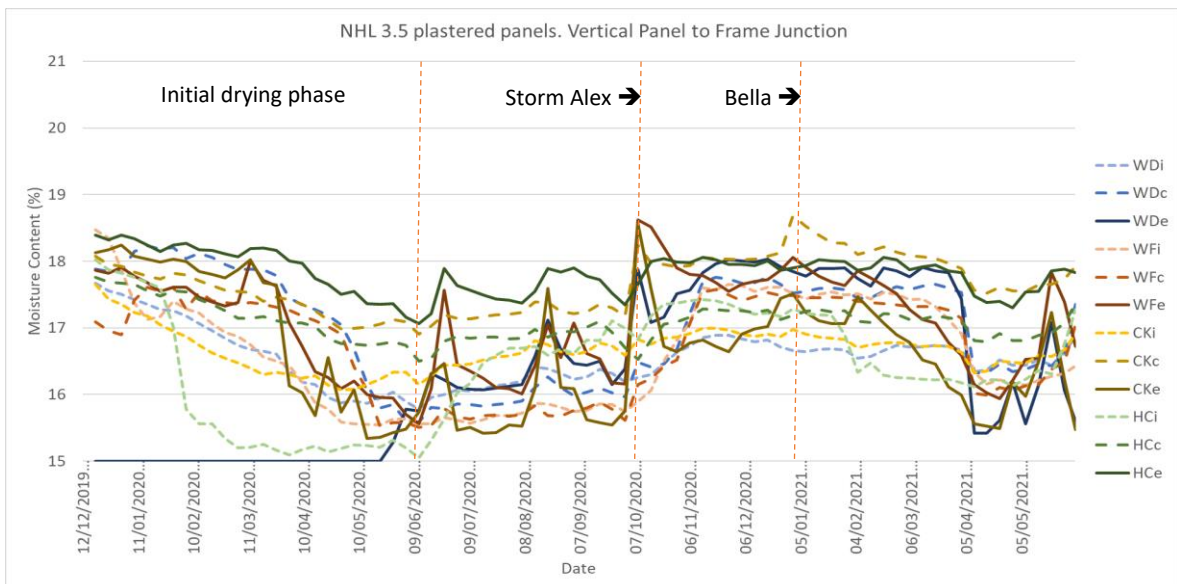
Figure 12. Results for monitoring period 12/12/2019-05/02/2021 for the monitoring position at the vertical junction between panel and oak frame for panels finished with NHL 3.5 plaster. (WD-Wattle & Daub, WF-Wood Fibre, CK-Cork, HL-Hemp-lime. i-internal, c-centre, e-external.)

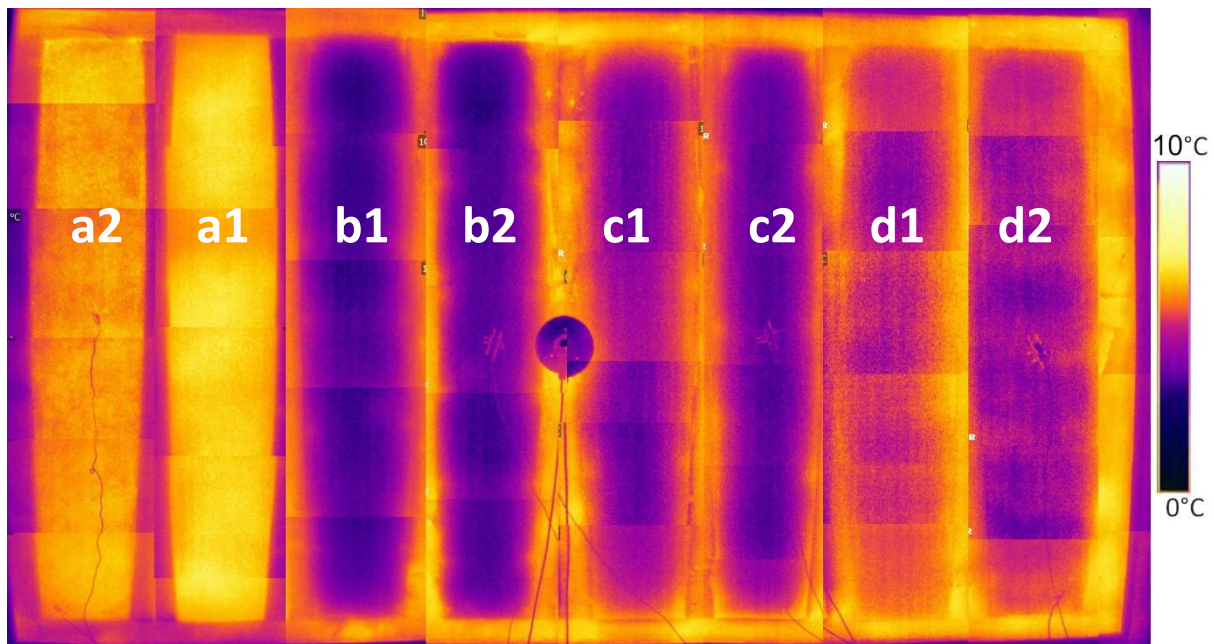
Figure 13 External thermography of test panels. Left to right, [a2](#)) wattle & daub with lime-hemp plaster, [a1](#)) wattle & daub with NHL 3.5, [b1](#)) cork with NHL 3.5, [b2](#)) cork with lime-hemp, [c1](#)) wood fibre with NHL 3.5, [c2](#)) wood fibre with lime-hemp, [d1](#)) hempcrete with NHL 3.5 and [d2](#)) hempcrete with lime-hemp plaster.

The thermography undertaken on 19/02/20 took place between 6:40am and 7:20am. The conditions were as presented in Table 2. The results are compiled as a composite image, as presented in Figure 13.

This demonstrates that the panels with the highest external surface temperature, and as such, the poorest thermal performance, are the wattle & daub, with the best performing being the expanded cork board. A small difference in external surface temperature can be seen within the pairs of panels, with those rendered in lime-hemp performing better than those rendered in NHL 3.5. The results of the second round of thermography took place [on the 19/11/2020](#) [and](#) showed very similar findings, with no significance differences between the two rounds.
