**Article title:** In-situ measurements of wall moisture in a historic building in response to the installation of an impermeable floor

**Authors:** Kevin Briggs[1], Richard Ball[2], Iain McCaig[3]

**Affiliations:** Department of Architecture & Civil Engineering, University of Bath, UK[1], Historic England, UK[2]

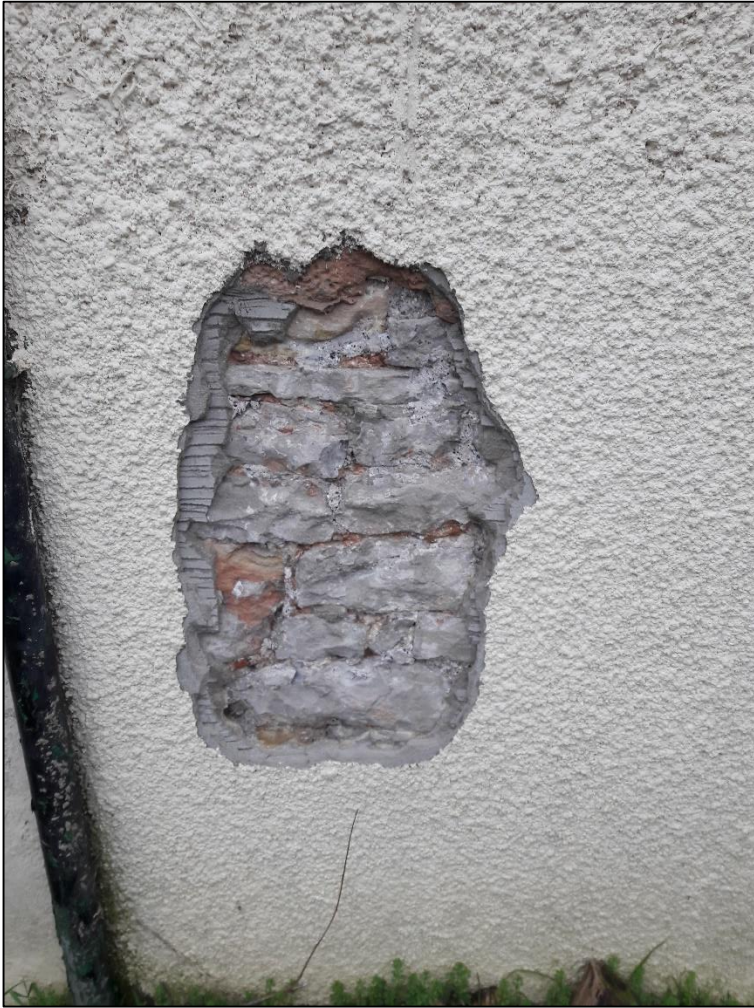
Figure 2: The external face of the pantry wall at Court House showing a rubble wall formed of Sandstone and Limestone blocks with a cement-based, three-coat render system.

A three-year monitoring programme was undertaken to measure moisture levels in a 600 mm thick, composite rubble-core masonry wall at Court House; a private residential property in Caldicot, Wales (Figure 1). Court House is a Grade II listed building originating from the 16<sup>th</sup> or 17<sup>th</sup> Century (DataMapWales, 2021). The masonry wall was located on the north elevation of the house and formed the external wall of an unheated, flagstone-floored room that was used as a pantry during the monitoring period (Figure 2).

Response – The internal photo is blurry and has been removed. We don't have a replacement photo, but the layout of the instrumentation is shown schematically in Figure 4. Figure 2 has been replaced by a photo of the external face of the wall, after removal of the external render as part of building works at the property.

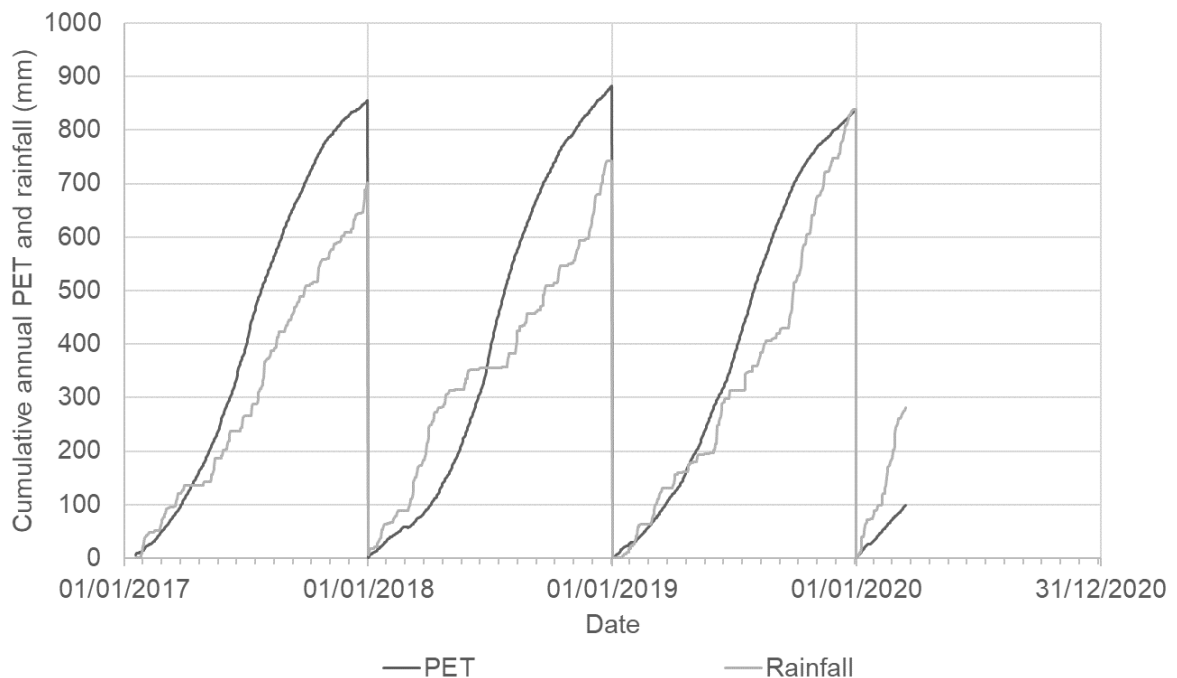
Figure 6: Cumulative annual potential evapotranspiration (*PET*, mm) and rainfall (mm) measured by the weather station at Court House. Note that the measurements start on 18/01/2017.

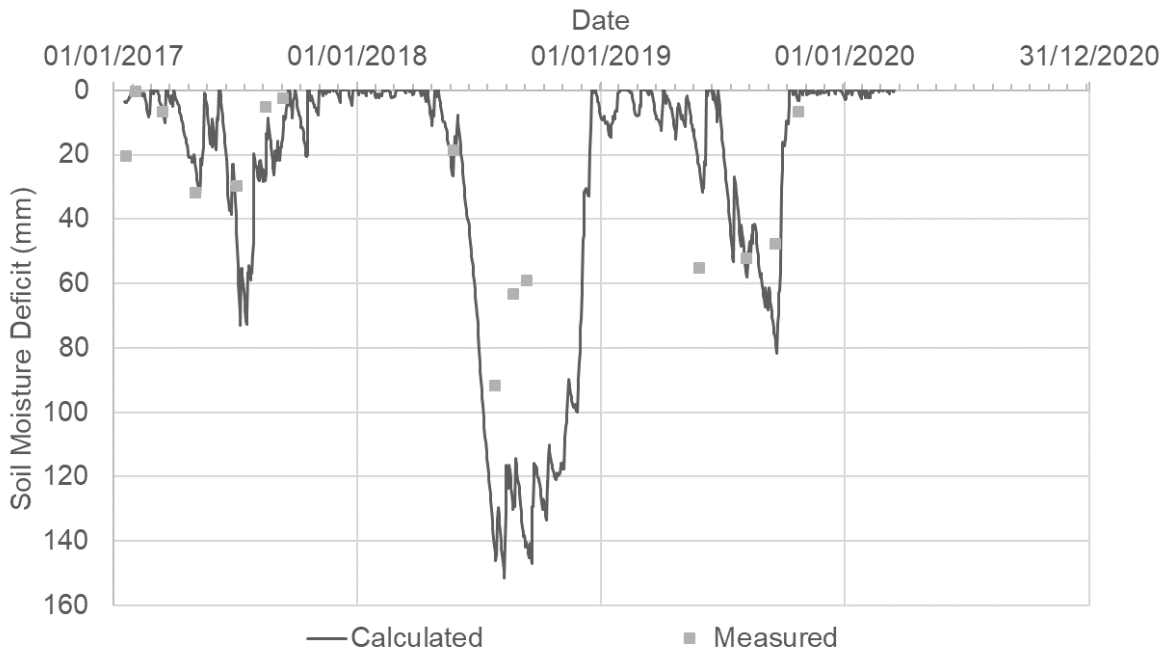
Figure 8: Soil Moisture Deficit (mm) at Court House (i) calculated using daily weather station data and (ii) measured using a PR2 soil moisture probe (up to 1m below ground level).

*Figure 8: Soil Moisture Deficit (mm) at Court House (i) calculated using daily weather station data and (ii) measured using a PR2 soil moisture probe (up to 1m below ground level).*

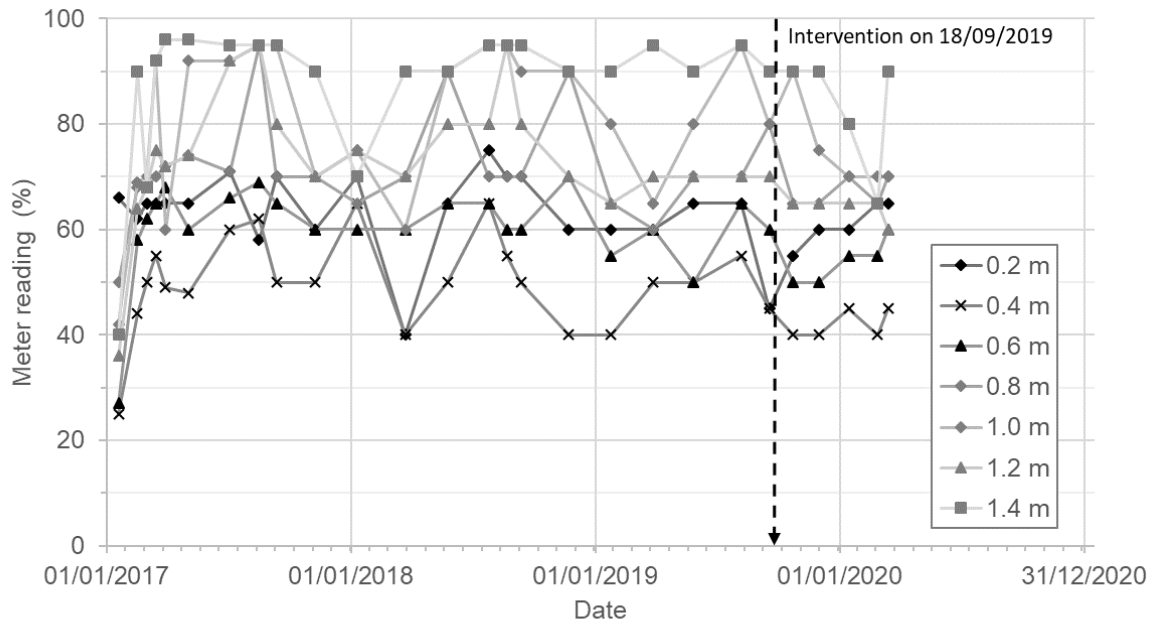
Figure 10: Protimeter Mini moisture meter readings of wood moisture equivalent (WME) measured between 0.2m and 1.4m above ground level over a three-year period between 2017 and 2020, including an intervention to seal the floor on 18/09/2019.

Figure 10 shows the wall moisture levels measured using the moisture meter with a deep wall probe. The wall moisture probe showed consistently lower meter readings at the base of the wall relative to the upper part of the wall. The meter readings were erratic and did not show a temporal trend. It is possible that the meter readings were responding to changes in the internal air temperature and humidity or were influenced by the distribution of salts within the wall (Franzoni & Bandini, 2012). They were not considered to be reliable measurements of wall moisture levels for this study.

*Figure 10: Protimeter Mini moisture meter readings measured between 0.2m and 1.4m above ground level over a three-year period between 2017 and 2020, including an intervention to seal the floor on 18/09/2019.*

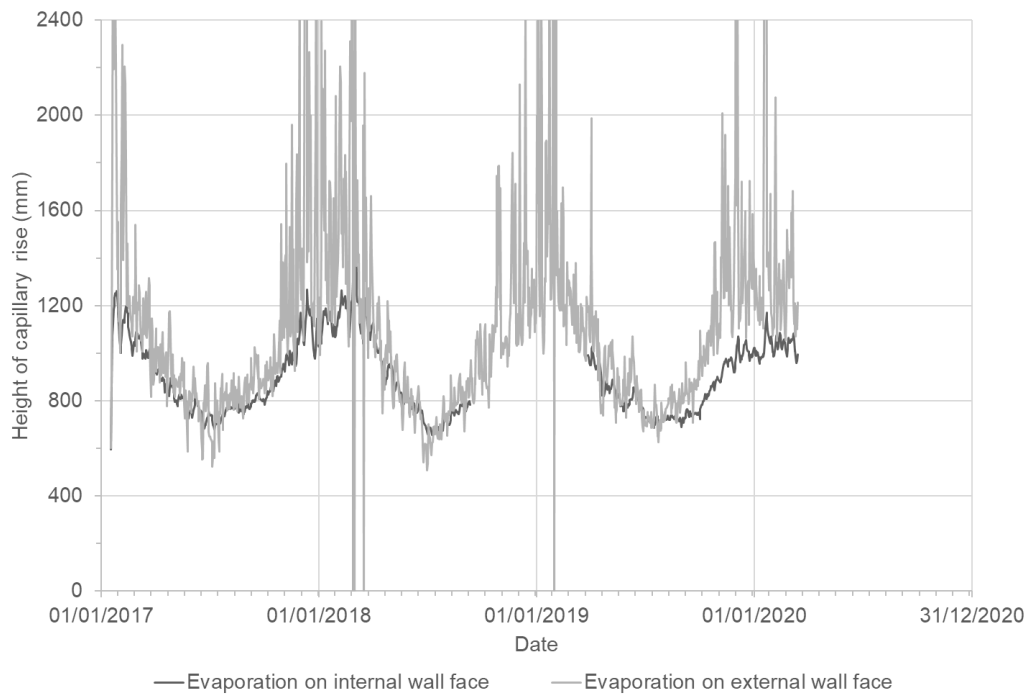
Figure 11: The height of wall capillary rise calculated using the Hall & Hoff (2007) sharp front model using PET derived from temperature and relative humidity data measured (i) On the internal wall face and (ii) On the external wall face. Note: Internal wall face data are missing for September 2018 to March 2019. Extreme capillary rise values for the external wall face have been omitted for clarity.

*Figure 11: The height of wall capillary rise calculated using the Hall & Hoff (2007) sharp front model using PET derived from temperature and relative humidity data measured (i) On the internal wall face and (ii) On the external wall face. Note:*

*Internal wall face data are missing for September 2018 to March 2019. Extreme capillary rise values for the external wall face have been omitted for clarity.*
