Article Title: Physical Vulnerability of Buildings to Flooding in Lilongwe City, Malawi

Authors: Mtafu A.Z.Chinguwa Manda, Chresceuntia Matambo Msasa

Physical Vulnerability of Buildings to Flooding in Lilongwe City, Malawi

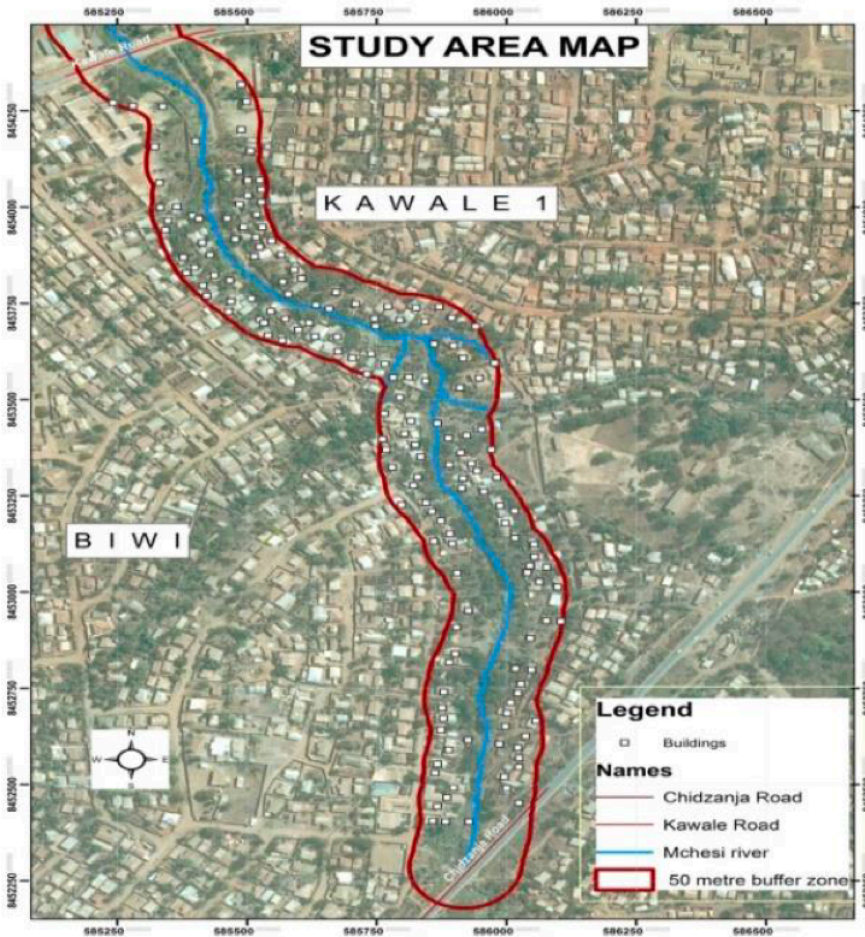
Figure 2: Biwi and Kawale1 study sites

The study was conducted in Lilongwe City (figure 1), which has, based on 2018 census, a population of 989,318 rising at 3.8% per year from 674,448 in 2008 (NSO, 2019). The study targeted two low-income settlements of Biwi and Kawale-1 and focussed on buildings within a 50-metre buffer zone along the Mchesi river, between Chidzanja and Kawale bridges (Figure 2). Stream reserves are prescribed by government departments such as the Department of Physical Planning which recommends 15 to 30m on either side of a river according its size (GoM,2014). This study used a 50 m river reserve to assess if buildings beyond the official zoning would be vulnerable to flooding. Mchesi river acts as a physical boundary between Kawale and Biwi Townships. The number of people settling on river banks such as that of Mchesi and other river reserves since the return to multi-party democracy in 1994 has been increasing (Manda 2005, p.15). The two settlements experience near annual flood events; the recent ones occurring in December 2017 and January 2019.

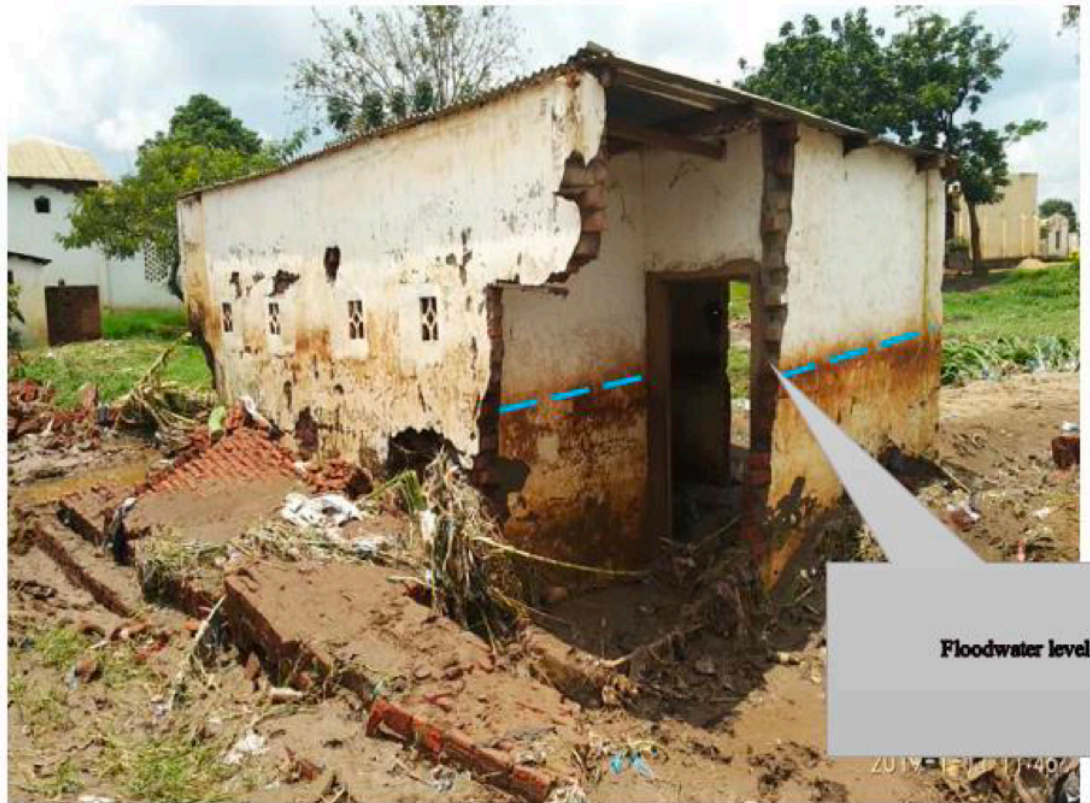
The results also show that over half (54%) of the buildings were inundated by high floodwater of over 60 centimetres (Table 6). Figure 4 shows floodwater level inside and outside of the building. Some of the buildings were damaged partly or had totally collapsed. The high number of buildings with high inundation level inside only shows that many buildings had low foundation levels which allowed floodwater to enter the buildings or protection measures like storm drains, brick fences and vegetation cover were not effective enough in reducing flood risk.

Figure 4a: Flood water level inside and outside a damaged house
