RESEARCH ARTICLE

## Hygrothermal monitoring of replacement infill panels for historic timber-frame buildings: initial findings

Whitman C, Prizeman O, Walker P, McCaig I, Rhee-Duverne S. Hygrothermal monitoring of replacement infill panels for historic timber-frame buildings: initial findings. *UCL Open: Environment*. 2022;(4):10. Available from: <https://doi.org/10.14324/111.444/ucloe.000039>

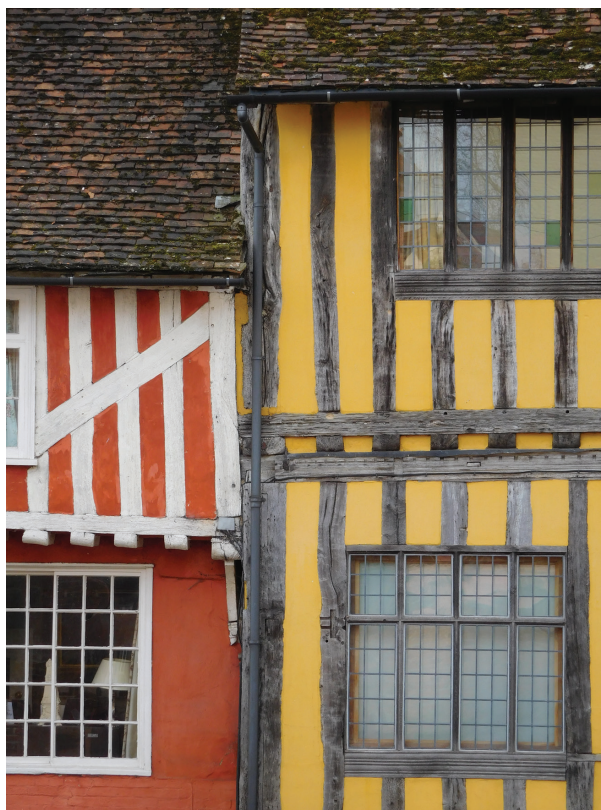
Fifteenth century timber framing, The Manor House (left) and 53 Church Street (right), Lavenham, Suffolk.

Traditional timber-framed buildings in the UK (Fig. 1) are most commonly constructed from oak, with some examples also found in elm and other native hardwoods [9]. The timbers form a framework, which is then infilled in a variety of materials, these varying depending on the age and geographical location of the building (Fig. 2).

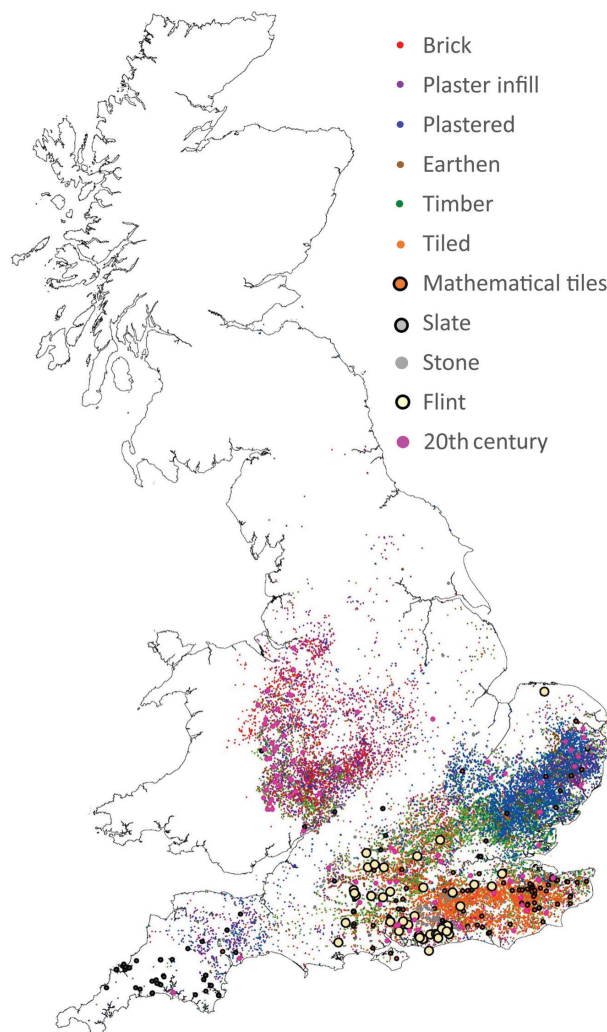
Figure 2

Distribution of exposed timber-framed buildings in Great Britain, classified by panel infill and cladding type.

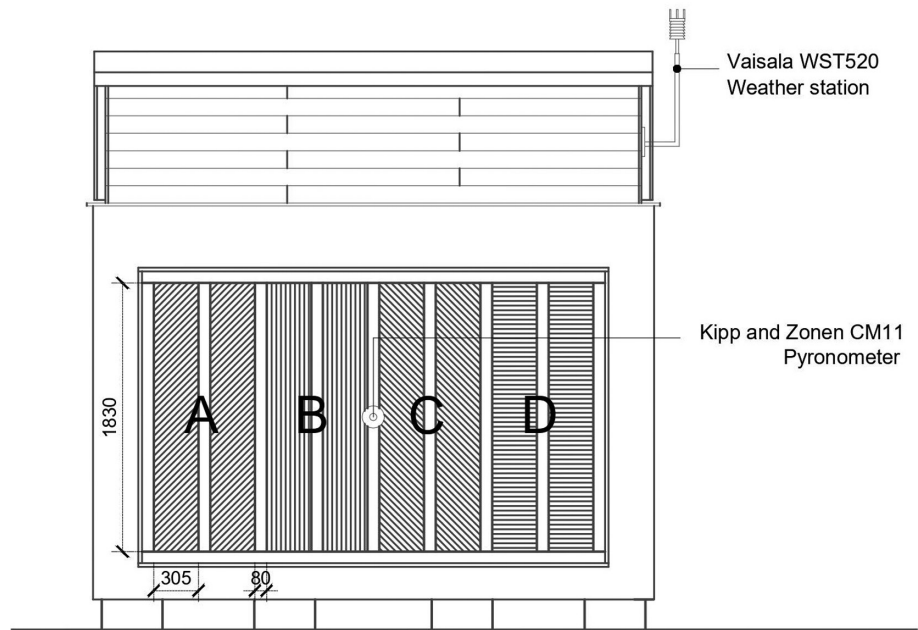
North elevation of test cell showing pairs of panels.

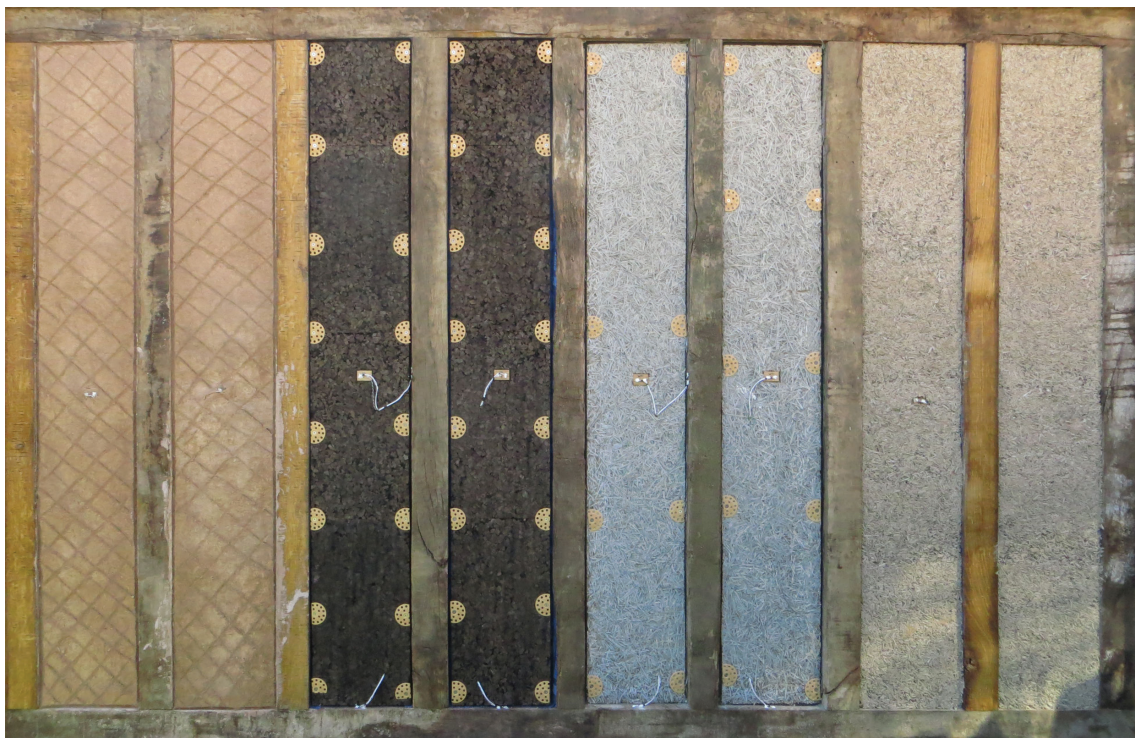
Figure 4

Photograph of panels prior to rendering.  
Source: Authors' own 2019.

A test cell with a controlled internal environment (internal dimensions 3.5 wide × 1.9 deep × 2.2 high) was constructed at Cardiff University. Test panels form the north wall of the cell and are exposed externally to the Cardiff climate. The dimensions of the test panels were determined using the results of a study of a representative sample of 100 historic timber-framed buildings with exposed timber frames [6]. This showed 53% to be square framed (of approximately equal width and height) and 47% close studded (tall thin panels). The average size of the square panels was 785 mm × 950 mm (width × height) and the close studded 305 mm × 1830 mm (width × height), approximately 1 ft wide by 6 ft tall. Given the configuration of the test cell, it was decided to construct close studded panels, allowing the monitoring of eight adjacent panels all at the same height above ground level (Fig. 3). This array of eight panels was constructed using reclaimed oak, and allowed for the monitoring of pairs of panels of four different infill solutions (Fig. 4).

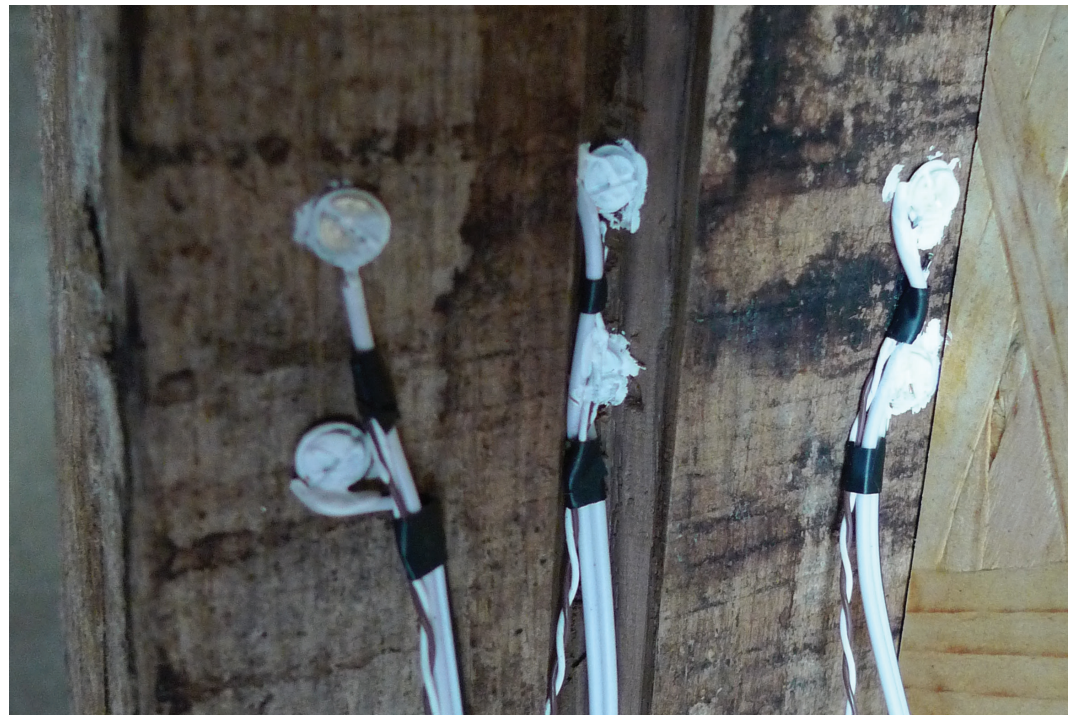
**Figure 6**

Pairs of stainless-steel screws embedded directly into the timber frame. The electrical resistance between the two is measured and used to calculate the moisture content of the timber.

Type T thermocouples were used to measure temperature (°C). Following a literature review [4, 20–23], electrical resistance was chosen as the measurement methodology for moisture content (%). This allowed continual measurement with minimal impact on the surrounding materials. A methodology based on the wood block/dowel methodology used by Dr Paul Baker at New Bolsover [3] and reported in Historic England Research Report 43-2016 [24] was followed. Pairs of stainless-steel screws were embedded at the monitoring points, set 20 mm apart along the grain. For monitoring points occurring at the junction between the infill panel and the timber frame, these were embedded directly into the oak frame (Fig. 6). For monitoring points within the depth of the panel, they were embedded in lengths of split oak lath (Fig. 7).

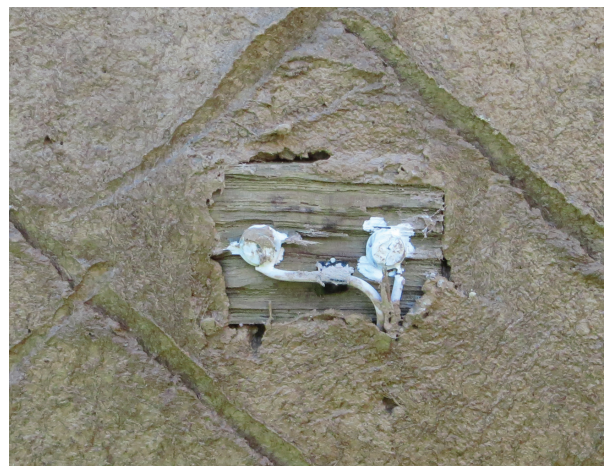
**Figure 7**

For points at the interface between materials where no timber exists, the stainless-steel screws were embedded in lengths of split oak lath.

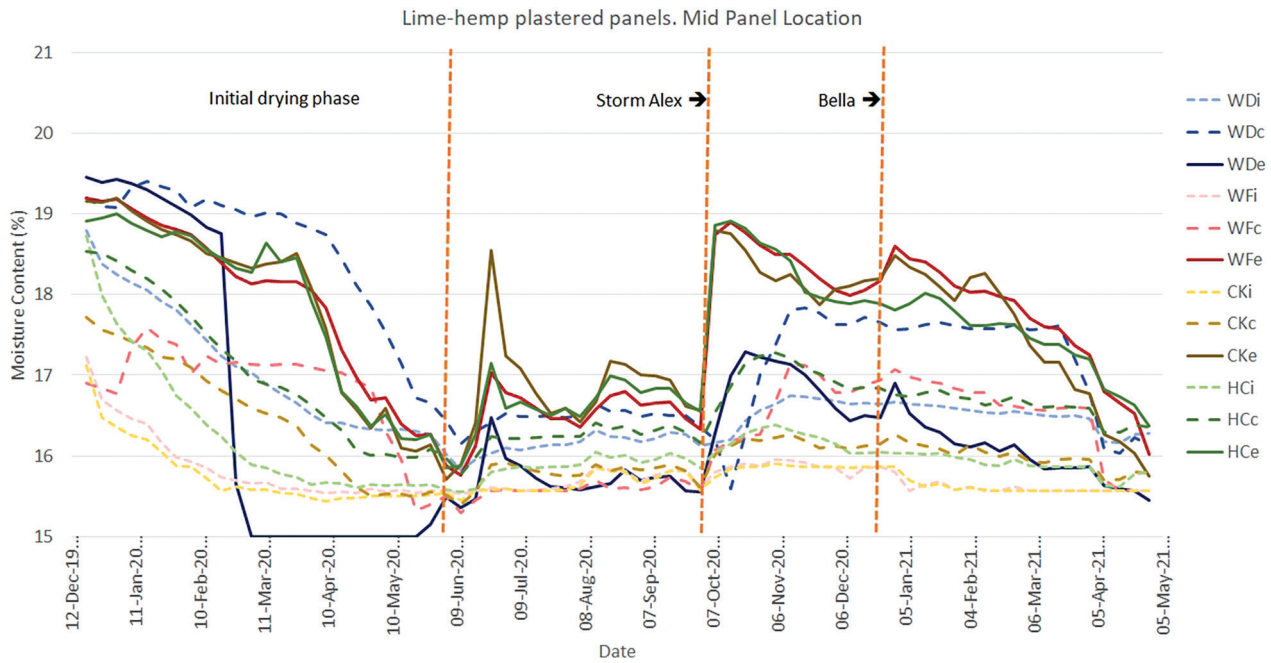
Figure 8

Results for monitoring period 12/12/2019–05/05/2021 for the mid-panel monitoring position for panels finished with lime-hemp plaster. Abbreviations: WD, wattle and daub; WF, wood fibre; CK, cork; HC, hempcrete; i, internal; c, centre; e, external.

The initial results (Figs 8–12) show an initial drying period followed by a series of wetting and drying cycles. To date, no evidence of interstitial condensation has been found, with these wetting cycles correlating with climatic measurements of wind-driven rain. The impact of two major storm events, Alex and Bella, are particularly prominent. Storm Alex was the event that saw a record-breaking wettest day on record [26]. A rapid increase in the moisture content at the interface between the external render and the infill material can be seen in all materials, with the lowest being that of wattle and daub (WDe), for those panels finished in hemp-lime (Fig. 8). It would appear that the lower moisture permeability of the other infill materials concentrates the moisture in the external render, whereas the more moisture permeable wattle and daub allows the moisture to penetrate deeper into the panel. A rise in moisture content being measured at the centre of the panel's depth (WDc) and at the interface between the infill and internal plaster (WDi) can be seen to follow. Over time, the moisture content at the central position (WDc) becomes higher than the external position (WDe), with this being maintained until the following spring. A

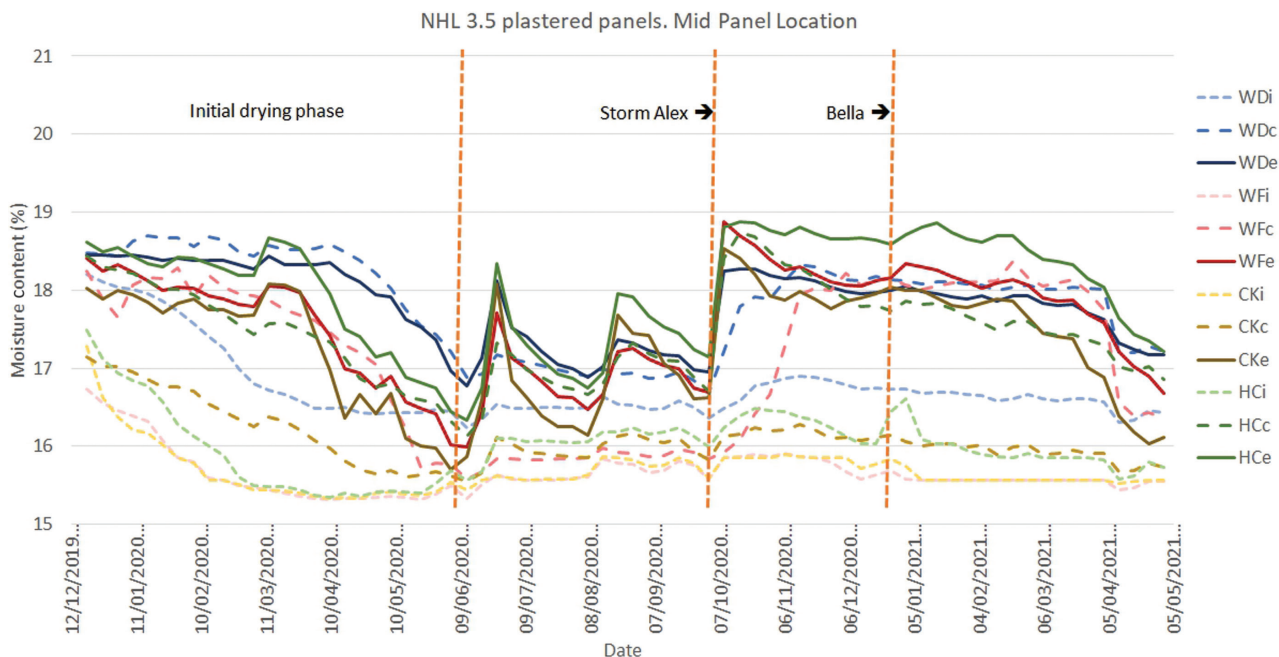
Results for monitoring period 12/12/2019–05/05/2021 for the mid-panel monitoring position for panels finished with NHL 3.5 plaster. Abbreviations: WD, wattle and daub; WF, wood fibre; CK, cork; HC, hempcrete; i, internal; c, centre; e, external.

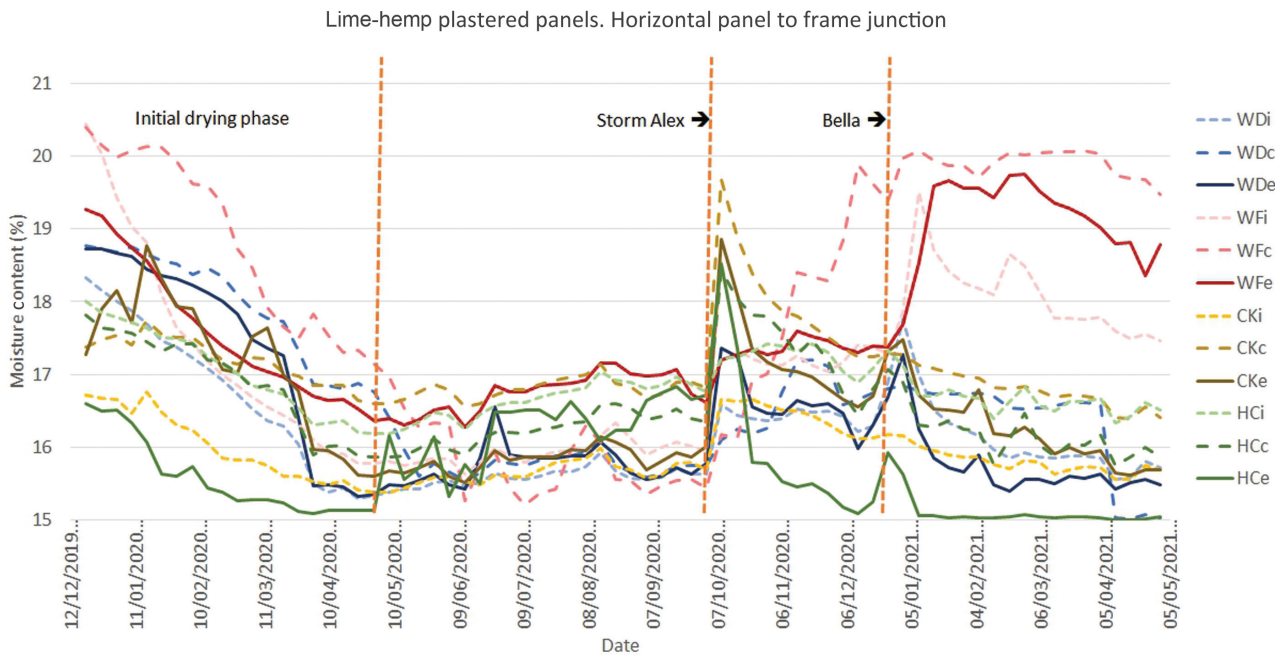
**Figure 10**

Results for monitoring period 12/12/2019–05/05/2021 for the monitoring position at the horizontal junction between panel and oak frame for panels finished with lime-hemp plaster. Abbreviations: WD, wattle and daub; WF, wood fibre; CK, cork; HC, hempcrete; i, internal; c, centre; e, external.

The results for the monitoring positions located at the junction between the base of the infill panels and the reclaimed oak frame (Figs 10 and 11), show a reduced initial drying period for those panels finished in lime-hemp plaster. Following the storm-induced wetting events, a substantial increase in moisture content is recorded at the centre of the wood wool/wood fibre panel’s depth (WFc). This is followed by an increase at both the internal (WFi) then the external positions (WFe), which continues for the following months. At the centre the moisture content remains around 20%, or more in the case of the panel finished in NHL 3.5, until the spring. The perimeter detail of this panel includes a bitumen impregnated expanding strip and mastic sealant [14], which potentially traps the moisture at this point. This highlights an area for further research and underlines the challenge that this exposed junction presents for both design and workmanship.

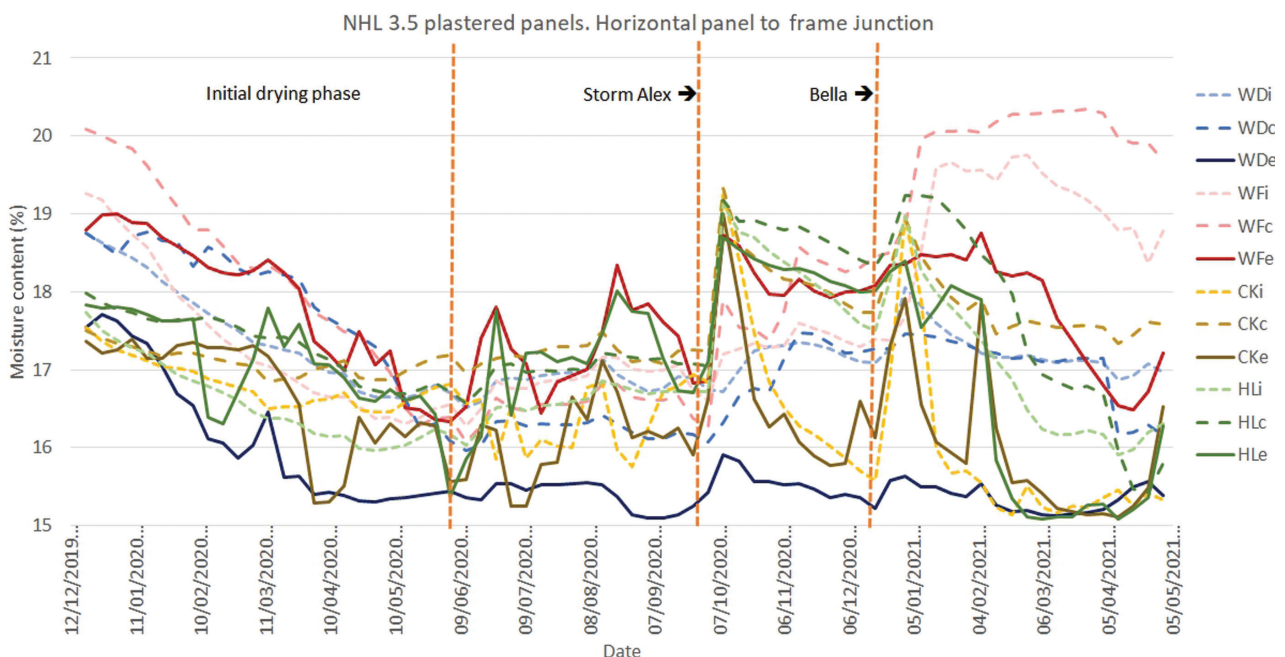
**Figure 11**

Results for monitoring period 12/12/2019–05/05/2021 for the monitoring position at the horizontal junction between panel and oak frame for panels finished with NHL 3.5 plaster. Abbreviations: WD, wattle and daub; WF, wood fibre; CK, cork; HC, hempcrete; i, internal; c, centre; e, external.

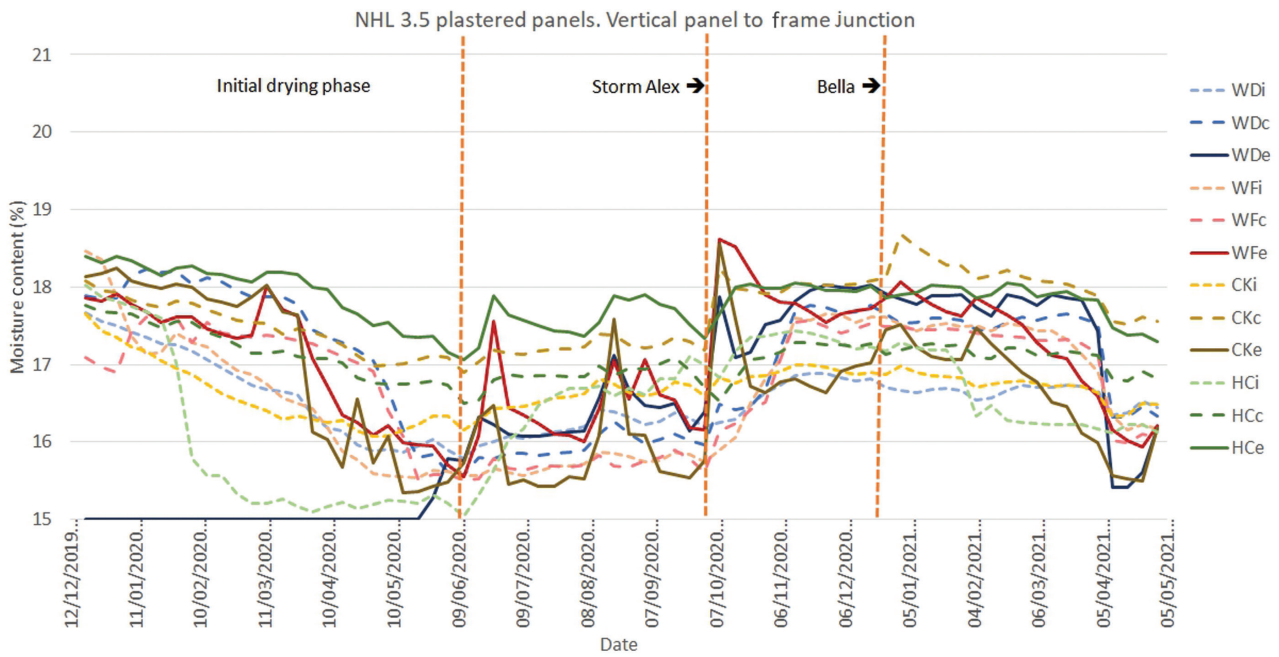
Figure 12

Results for monitoring period 12/12/2019–05/05/2021 for the monitoring position at the vertical junction between panel and oak frame for panels finished with NHL 3.5 plaster. Abbreviations: WD, wattle and daub; WF, wood fibre; CK, cork; HC, hempcrete; i, internal; c, centre; e, external.

The moisture contents at the vertical junction between panel and frame (Fig. 12) are overall lower than those for the horizontal junction (Figs 10 and 11), most probably due to gravity permitting drainage down the joint. The highest moisture content is measured at the centre of the expanded

cork board’s depth. An expanding foam sealant is also used here and similarly may be trapping moisture. Further investigation is needed to compare the use of moisture permeable and non-moisture permeable solutions to this interface.

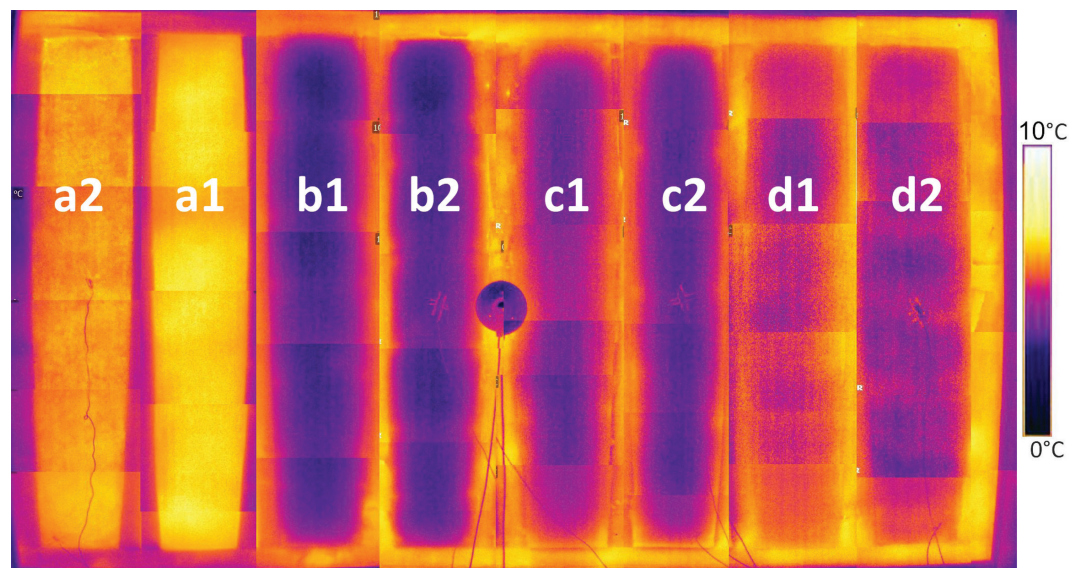
Figure 13

External thermography of test panels. Left to right, a2) wattle and daub with lime-hemp plaster, a1) wattle and daub with NHL 3.5, b1) cork with NHL 3.5, b2) cork with lime-hemp, c1) wood fibre with NHL 3.5, c2) wood fibre with lime-hemp, d1) hempcrete with NHL 3.5 and d2) hempcrete with lime-hemp plaster.

The thermography undertaken on 19/02/20 took place between 6:40 am and 7:20 am. The conditions were as presented in Table 2. The results are compiled as a composite image, as presented in Fig. 13.

The results of the two rounds of in situ U-value measurements (Table 3) corroborated the results obtained by thermography. It had been hoped for a greater difference in moisture content between the first measurements undertaken during the initial drying period and those at the end of the year. However, as noted above, the wetting brought by the storm events resulted in very similar moisture contents. Notwithstanding, there can be seen to be an improvement in the thermal performance of the hempcrete panels over time.
