Article title: Moisture Buffering and Mold Growth Characteristics of Naturally Ventilated Lime Plastered Houses.

Moisture Buffering and Mold Growth Characteristics of Naturally Ventilated Lime Plastered Houses.

Lime plaster is well known for its moisture-buffering capabilities but is also susceptible to mold growth. This work focuses on the hygrothermal performance of lime plaster in naturally ventilated residential spaces. Surveys are carried out for 45 traditional buildings of Ahmedabad in India with measurements of ambient variables, such as temperature, relative humidity, wall moisture content, etc. The Mold growth patterns of these spaces are related to the measured variables and wall characteristics. Hygrothermal simulations of some spaces are also carried out to observe the moisture buffering of lime plaster. Experimental observations have been contrasted with numerical simulation results to see if the numerical predictions of the hygrothermal models are realistic.

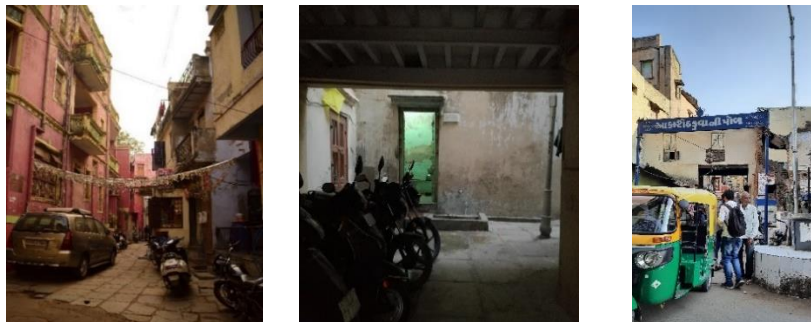
Figure 1 Pol Houses

Two different types of naturally ventilated lime-plastered houses were surveyed in the city of Ahmedabad. Ahmedabad falls in the hot-dry climate zone of India. The heritage city of Ahmedabad includes thousands of Pols, a dense cluster of residences belonging to people of the same caste, religion, and occupation. For more than 300 years, these neighbourhoods are popularly known as Pol houses. The passive strategies in the design of Pols are prominent. Strategies protecting the inside spaces from direct heat gains include mutual shading, thick walls, long shared walls, central courtyard, multi-story structure, narrow lanes, dense clusters, etc. (32). The ota (plinth) outside the house is usually used to dry clothes in some houses. Attached to the ota (plinth) is a small, dedicated space for washing utensils and toilets. The construction of the house is of timber, brick, and lime plaster.

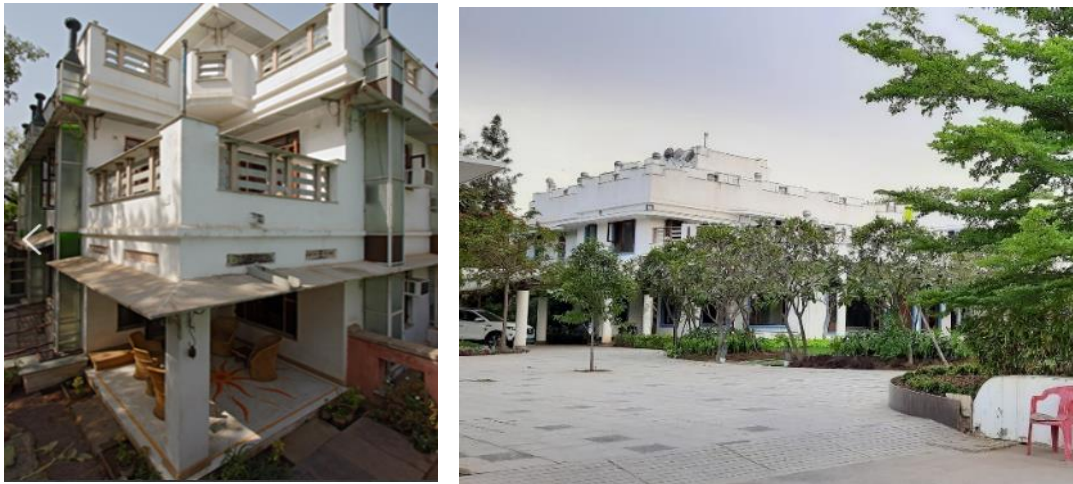
Figure 2 (a) Girikunj Residence (Source: Abhikram Architects); (b) RSR Residence

Detached lime-plastered residences were also studied and are shown in Figure 2. Girikunj Residence (Figure 2a) is a residential bungalow (33), designed using passive design strategies and traditional materials and methods. The ventilation system is well designed using glass exhaust shafts on the periphery. These shafts collect hot air from the small grill outlets in the spaces when the windows are closed. Air vents attached to it exhaust this air to the outside. Lime is employed for plastering, wall wash, and mortar. It consists of additives like Gur (jaggery), Gugal (Indian bdellium), and Methi (fenugreek) for improving binding and waterproofing.

The RSR Residence (Figure 2b), a bungalow designed by Abhikram Architects (40), is constructed using lime mortar and lime plaster. The type of lime plaster used is Marmarino lime plaster which gives a marble-like finish. The walls were not coated with paint. Mechanical ventilation is provided with the help of exhaust fans and air vents throughout the space.

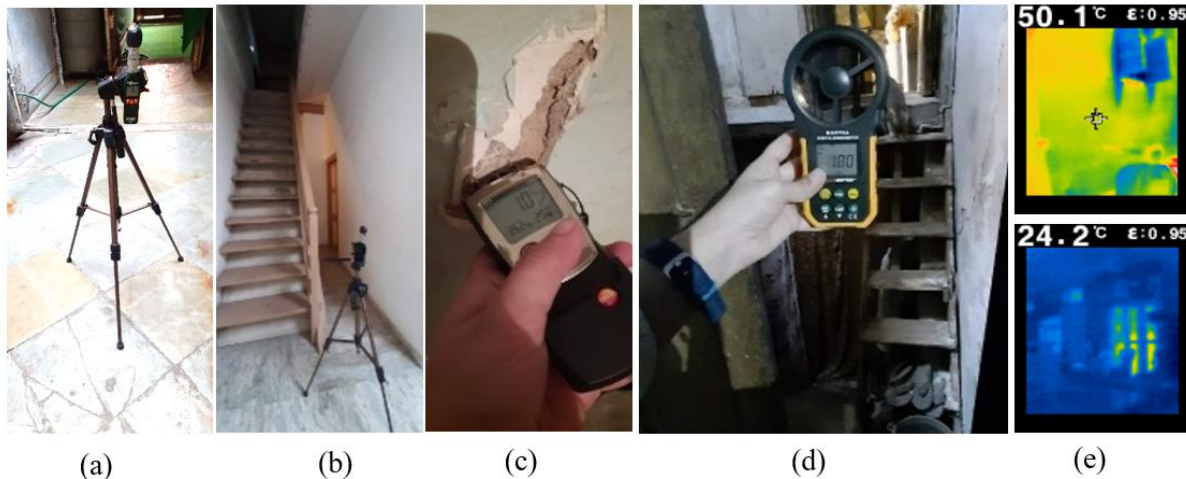
Figure 3 Site Measurements using several instruments

Point in time measurements (Figure 3) of the outdoor air temperature, relative humidity, globe temperature, and air velocity were noted for each space. Similarly, inside air temperature, relative humidity, globe temperature, and air velocity at the center of the space were measured. For measuring the inside surface temperatures of all the walls, the emissivity of the FLIR thermal Gun was set to 0.95. The surface temperature of the ceiling and floor was also noted.

The details of the instruments employed for measurements in Figure 3 are the following:

- (a) Outdoor Air, RH, and Globe temperature using EXTECH Heat Stress meter,
- (b) Indoor Air, RH, and Globe temperature using EXTECH Heat Stress meter
- (c) The Moisture Meter reading of exposed lime plaster (TESTO Moisture Meter: 606-2),
- (d) Air velocity reading using Vane Anemometer (PEAKMETER MS6252A) and
- (e) Surface temperature readings of external and indoor walls using Thermal Gun (FLIR: TG165).

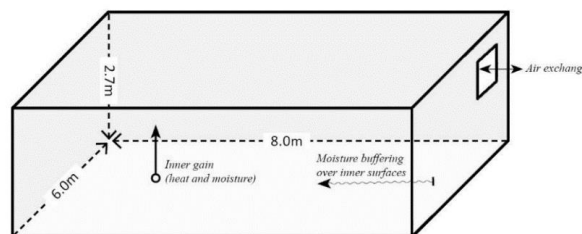
Figure 4 BESTEST Geometry (Source: (34))

Before simulating the surveyed spaces, preliminary simulations are worked out with the Building Energy Simulation Test (BESTEST) geometry (34). These simulations are carried out with both the EMPD (Effective Moisture Penetration Depth) (35) and thermal-only i.e. the conduction transfer function (CTF) models of Energy Plus (31). The EMPD model considers the moisture absorption and desorption at wall surfaces, while the thermal-only model ignores it completely. The purpose of employing these two models is to check whether moisture absorption and desorption at the wall surfaces are captured by the EMPD model. Several authors (4,35–37) have employed the BESTEST geometry in their hygrothermal studies. Figure 4 shows the BESTEST geometry which is a single-zone space of 8m x 6m x 2.7m. The space has a moisture source of 500 g/h from 9 a.m. to 5 p.m. and a constant air change rate of 0.5 air changes per hour for Ahmedabad weather. The walls are assumed to be made of brick walls. For the inner wall surfaces finishing materials such as gypsum plasterboard, plywood, and lime plaster are considered.

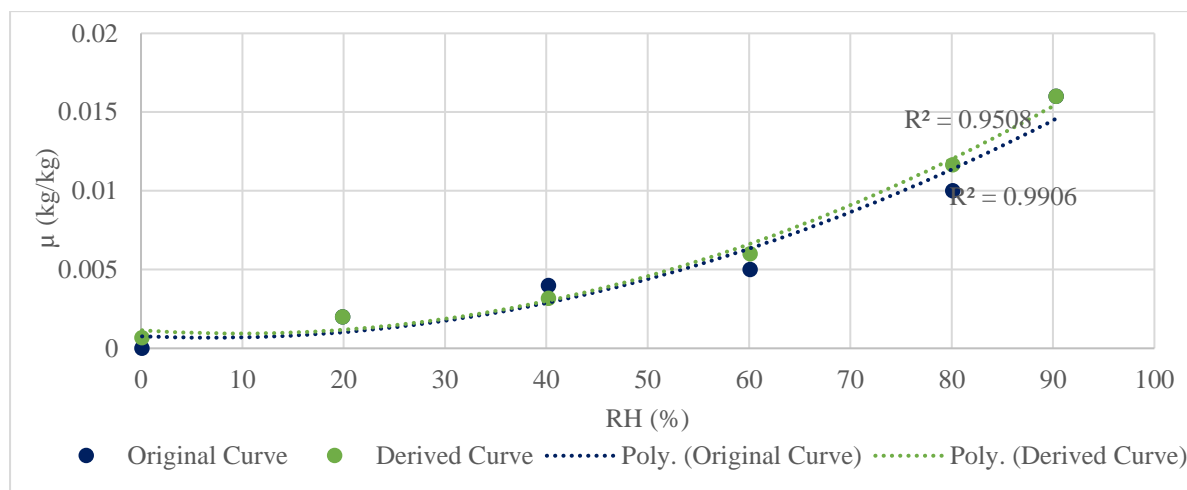
Figure 5 Best-fit sorption curve for lime plaster

It is a challenge to derive a universal sorption curve for lime plaster as its composition is site-specific and varies from region to region. The sorption curve was derived from the moisture content values of building materials available in the literature (39). The sorption coefficients were then derived through these moisture content values by a close-fitting curve as shown in Figure 5. The difference observed between the curves is very minuscule with a maximum difference of $0.002 \mu(\text{kg}/\text{kg})$. These values were then fed into the EMPD model to carry out simulations. After carrying out hygrothermal simulations for BESTEST geometry, a sample surveyed space is simulated with the EMPD model. The change in mean radiant temperature (MRT), relative humidity, and surface temperatures were observed through simulations. This further helped to predict the trend of the hygrothermal behaviour of lime plaster in that space throughout the year. The weather files for simulation are taken from Energy Plus weather data. ([Ahmedabad weather data](#)).

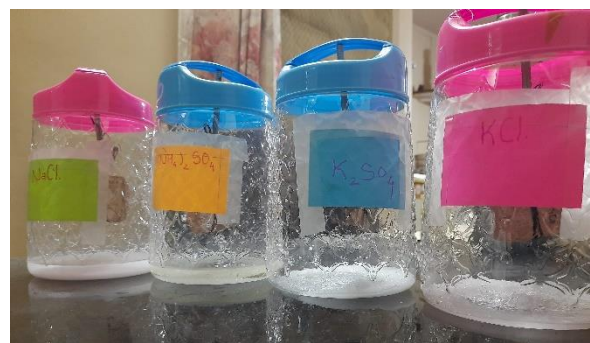
Figure 7 Lime plaster samples used for experiment Figure 6 Jars containing different salt solutions

To understand the onset of mold growth on lime plaster, an experiment similar to (40) was carried out. Different relative humidity levels were maintained in containers by different salt solutions. For this experiment, four plastic containers were filled with different salt solutions as shown in Figure 6. Table 2 shows the different salts and the quantity of salt and water to maintain the RH level inside the container. Preliminary trials were carried out by trial and error to fix the amount of salt and water to obtain the specific RH value. The temperature and relative humidity loggers (Hobo U10) were attached on the inner side of the lid of the jars to ensure constant relative humidity inside the containers.

The samples of lime plaster (see Figure 7) contained one part of lime putty, one and a half parts Surkhi (red brick powder), and two parts of sand in the mixture. Additives such as jaggery water and Gugal (Indian bdellium) water were also mixed. Using Hobo loggers (U10 Temperature and humidity loggers), the relative humidity was logged for four weeks to check the relative humidity levels inside. Once the desired RH levels were achieved, lime plasters samples of equal size (40mm x 40 mm x 10 mm), weight, and composition were introduced into the containers. These samples were left unattended until the visible mold was observed on the surface.

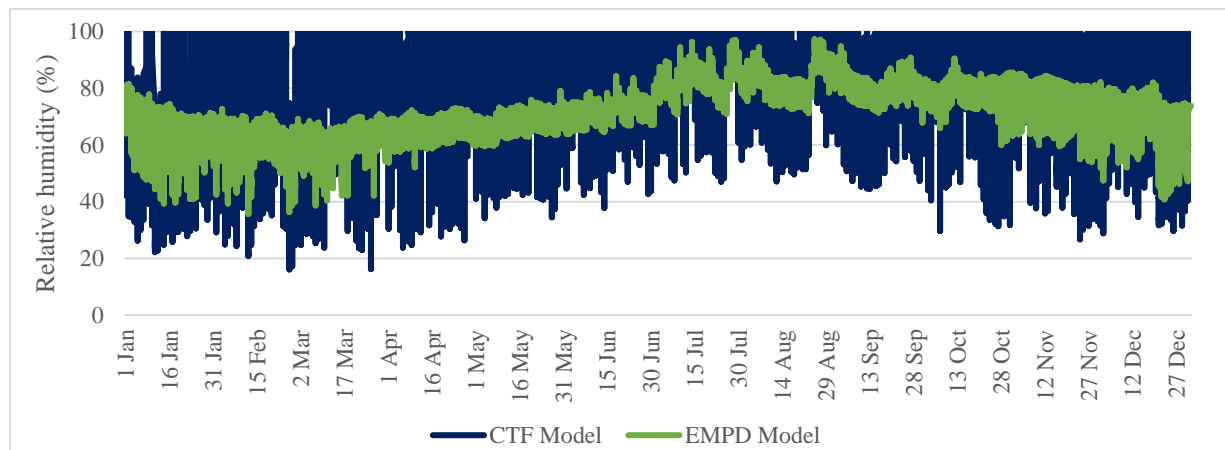
Figure 8 Relative Humidity of space with CTF and EMPD Models

Figure 8 shows the relative humidity (RH) in the space with lime plaster as the finish material for inside surfaces. The contrast in the RH levels of thermal-only (CTF) and EMPD models is visible. In the case of the CTF model, the RH levels go up to 100%. While with the EMPD model, the RH levels are maintained between 39% to 95%. Thus, the EMPD model (31) captures the moisture buffering effect of lime-plastered wall surfaces.

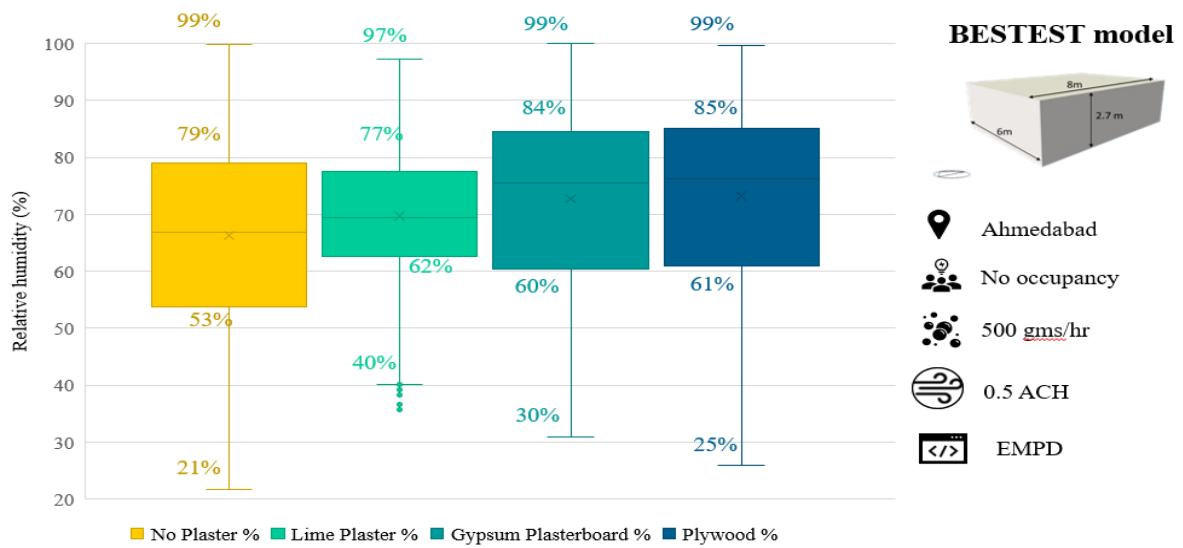
Figure 9 Indoor relative humidity in different materials

Simulations with the EMPD were also carried out with gypsum plasterboard, and plywood as inner surface finishes. Figure 9 shows the box plot of RH values for the different cases. Amongst the different surface finish materials, lime plaster showed the least variation in RH levels and the least amplitude. In cases of gypsum plasterboard, plywood, and no plaster material the maximum RH is 99%. While the maximum RH with lime plaster was about 97%. RH values with lime plaster and plasterboard don't drop below 30% for the given conditions. Also, 50% of the time RH with lime plaster was in the range of 62% to 72%. The RH values were lower during moisture increase and higher during moisture

reduction with lime plaster. The above confirms the better performance of lime plaster over the rest of the finish materials.

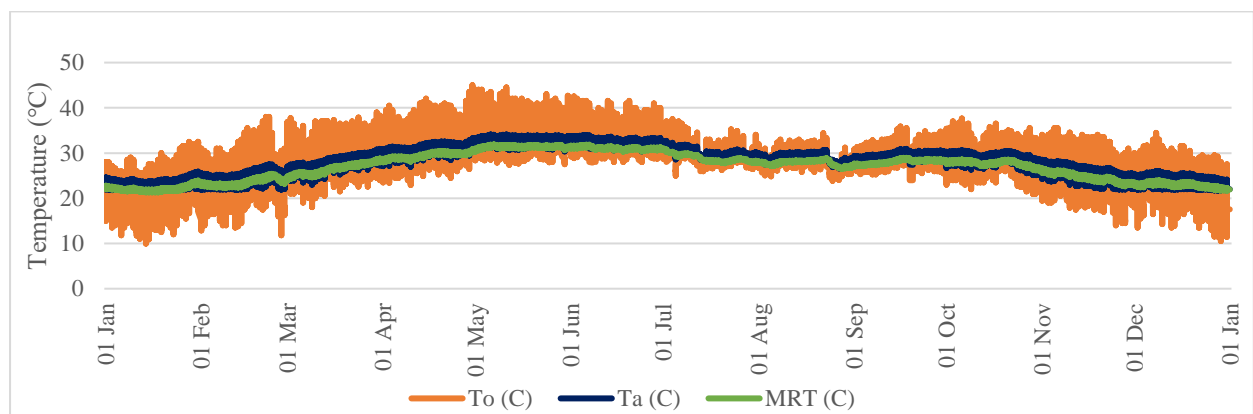
Figure 10 Outdoor, indoor, and mean radiant temperature in space PT_B

Figure 10 shows the temperature variations observed from outdoor to indoor throughout the year for space PT_B. The outside DBT varied with a maximum diurnal variation of 20°C and a minimum variation of 7°C. The indoor air temperature variation is around 5°C. Similarly, the variation of the MRT inside the space was around 2°C and was maintained between 20 to 30°C for this space.

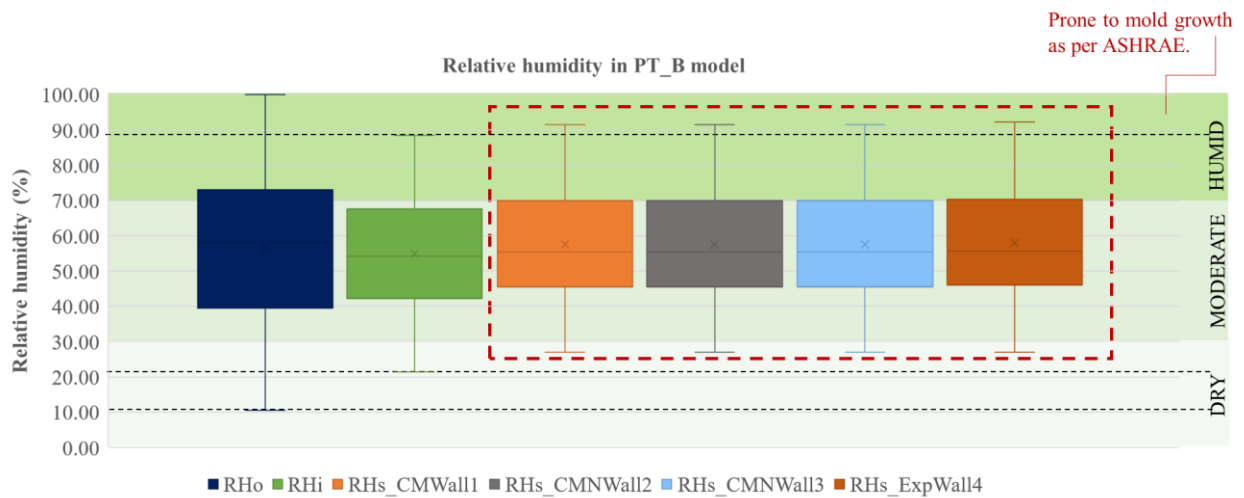
Figure 11 Indoor and surface relative humidity levels in PT_B

The outdoor RH levels were compared with indoor and surface RH levels in Figure 11. The outdoor maximum was 11.5 units higher than the indoor maximum and the outdoor minimum was 11 units lower than the indoor minimum. Also, the difference between the first quartile and third quartile was 33% for outdoor RH and 24% for indoor RH. It was observed that the surface RH levels were higher than the indoor RH levels. The RHs maximum was higher by 3 units while the RHs minimum was

higher by 7 units when compared to the maximum and minimum values of RH_i. To prevent mold growth, ASHRAE suggests that it is necessary to keep the spaces below 60% RH (41). However, 25% of the surface RH values were more than 70% leading to mold risk.

Similar to the simulation results (refer Figure 11), surface RH levels were higher than the indoor RH levels. 50% of the indoor readings were higher than outdoor indicating a humid indoor environment. The minimum values of surface RH were 9.8 to 12.4 units higher than the minimum indoor RH. The maximum surface RH is 4.3 to 8.3 units higher than the maximum indoor RH. If the above pattern is followed throughout the year, whenever the space RH goes above 60%, the surface RH will be around 65 to 70 % RH. In the monsoon period, when the outside RH levels are in the range of 80-95%, the surface RH of the walls could reach 95 to 97%. These RH levels are favourable for mold growth unless the moisture is removed from the surface.

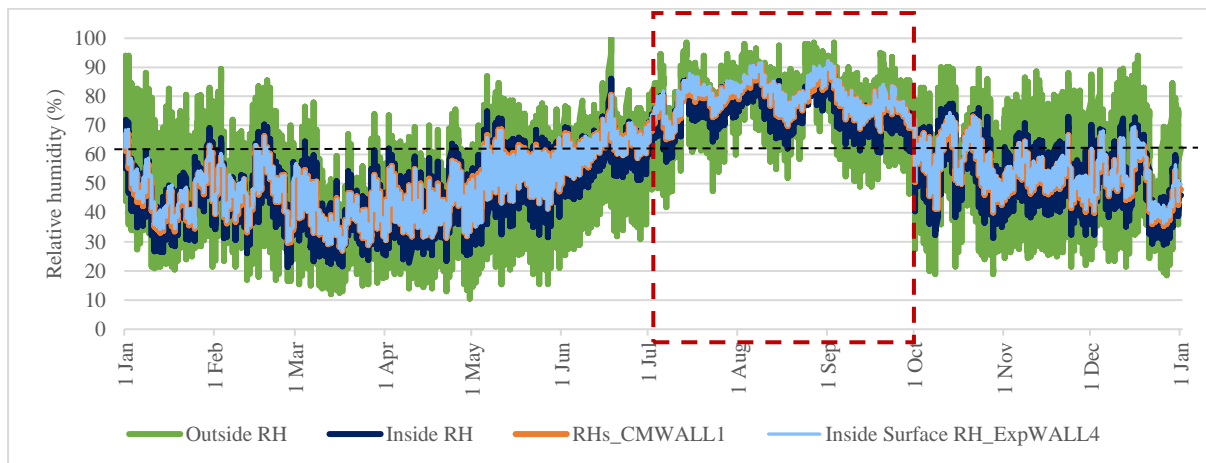
Figure 12 Relative humidity levels throughout the year in PT_B

Figure 12 indicates varying RH levels over the year. During the monsoon months (from July – October), the indoor RH was always above 60%. While the surface RH of the walls was always above 68%. These are the months when the wall surfaces are highly prone to mold growth.

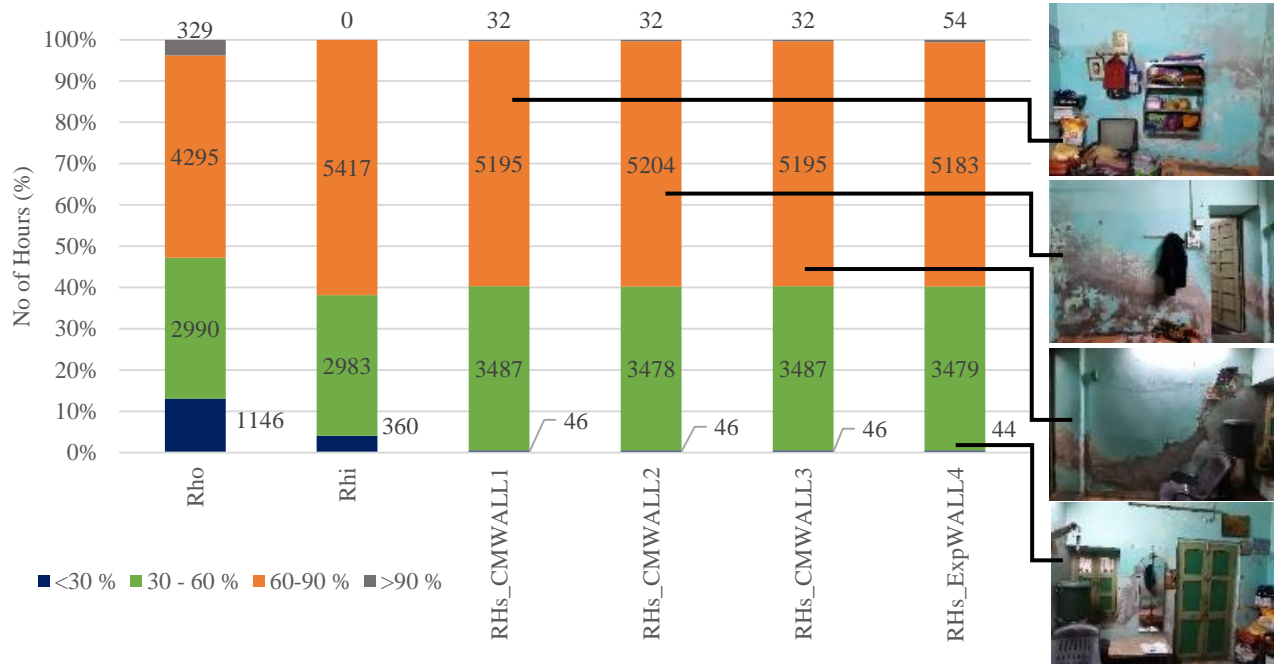
Figure 13 Hours corresponding to relative humidity ranges over the year

The percentage of hours when RH levels were favourable for mold growth is shown in Figure 13. Out of 8760 hours, 32 to 54 hours were above 90% RH near the walls. 60% of the hours were between 60% - 90% RH resulting in a risk of mold growth. Even though, the simulation results show an equal percentage of high RH near the walls, the percentage of mold growth observed on-site over each wall was different. This could be because of the varied placement of furniture, openings, and air velocity adjacent to each wall.

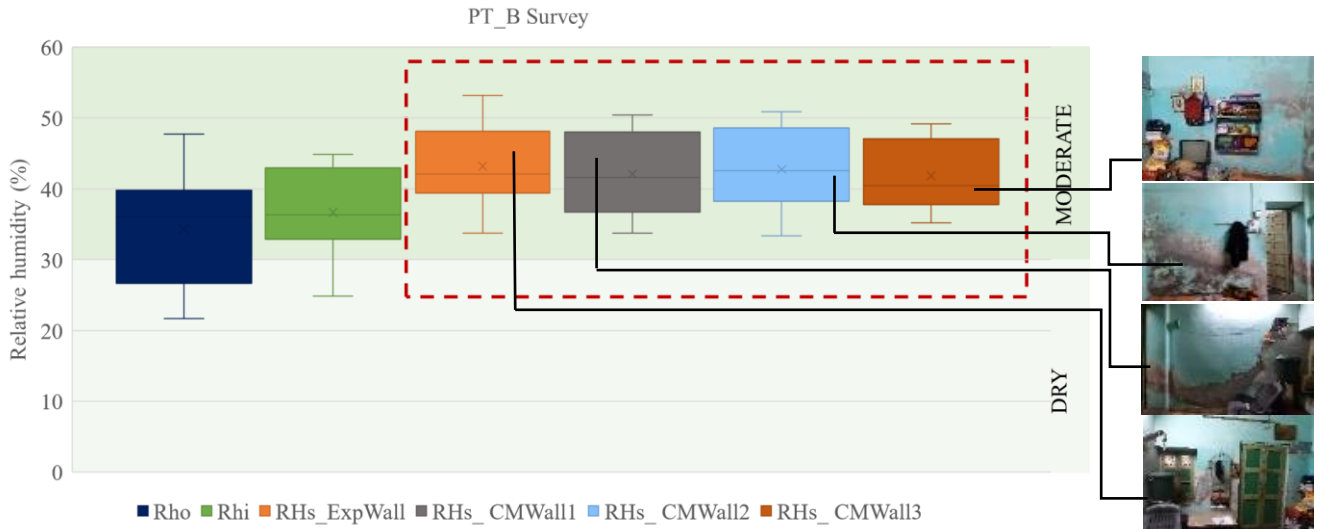
Figure 14 Onsite relative humidity levels inside PT_B

The surveyed Pol houses were categorized according to the coatings used over lime plaster. During the study period (December to March) the RH levels varied between 10 % - 55 %. The indoor minimum values of RH were higher by 2.1 and 1 units in the case of lime-washed and non-porous painted walls. Slightly higher indoor RH levels could be due to indoor occupancy and moisture generation. To further examine the simulation observations for sample space PT_B, the onsite readings were analyzed. In Figure 14, the outdoor relative humidity is compared with the indoor and surface RH levels from January to March.

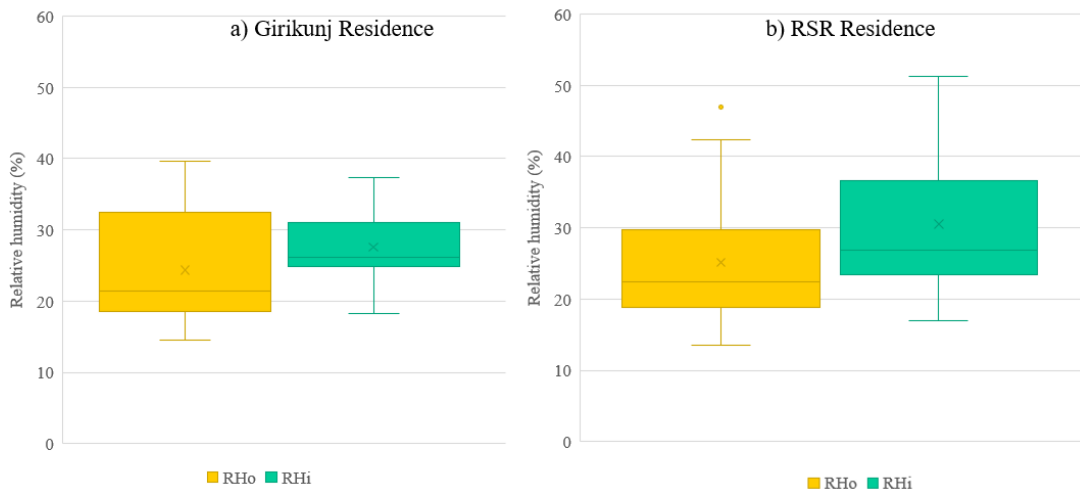
Figure 15 Indoor relative humidity of different spaces

For Girikunj Residence, the surveyed spaces included a basement and topmost rooms exposed to the sun. Figure 15a shows the relative humidity in the study period of March. The outdoor RH near Girikunj varied between 14.6% to 40%. The RH in indoor spaces varied between 18.2% to 37.4%. A difference of 3% to 4% was observed between the high and low values from outdoor to indoor. No water activity or occupancy (excluding the surveyor) was observed inside any of these spaces.

month of March. Figure 15b shows the indoor and outdoor RH levels. The mean of indoor RH was higher than that of outdoor by 4.7%. Mold growth was observed in one of the spaces (RJ_K). In this space, the indoor RH was higher by 8 to 14 units and a maximum difference of 18 units was observed between the surface RH and indoor RH. An adjacent space, RJ_J, was found to be free of mold. The indoor RH in RJ_J space was higher by 1 to 5 units while the surface RH was higher than indoor RH by 5 to 9 %. Thus, the correlation between higher surface RH and mold growth was observed through on-site surveys.

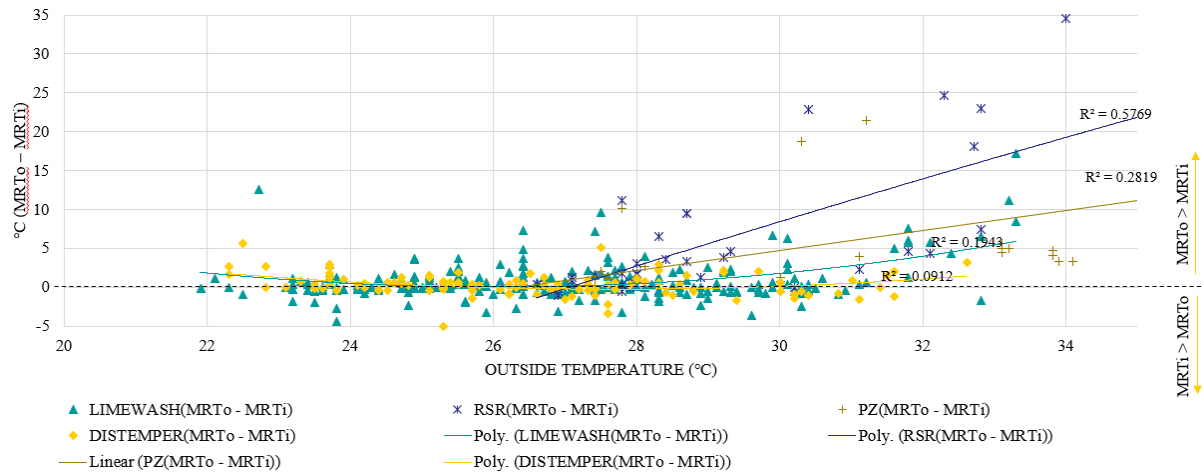
Figure 16 MRT Variation with outdoor temperature for different spaces

Figure 16 shows the difference between outdoor and indoor MRT for all the studied spaces. The MRT of space was calculated as per the formula given in (42). With increasing outdoor temperatures, the difference increases for all the spaces except those having a nonporous coating over lime plaster. A positive difference shows that the indoor MRT is lower than the outdoor MRT. The differences were highest (indicated by a steeper trendline) for RSR residence where lime plaster was exposed. The differences for Girikunj were lower than RSR residence and least for Pol houses with limewash.

The indoor was considered to be comfortable when inside MRT (MRT_i) was found to be lower than the outside MRT (MRT_o). Based on above criteria, it was observed that the spaces with non-porous paint were hot 30 % of the time. Limewashed spaces in Pol houses remained hot for 18.5 %, while RSR and Girikunj residences stayed hot for 8.6 % and 7.4 % respectively. Thus, RSR and Girikunj Residences were comfortable for more than 90% of the time. Pol houses with limewash were comfortable for 81% of the time in March. These differences could be more in hotter months and need to be studied further by year around measurements.

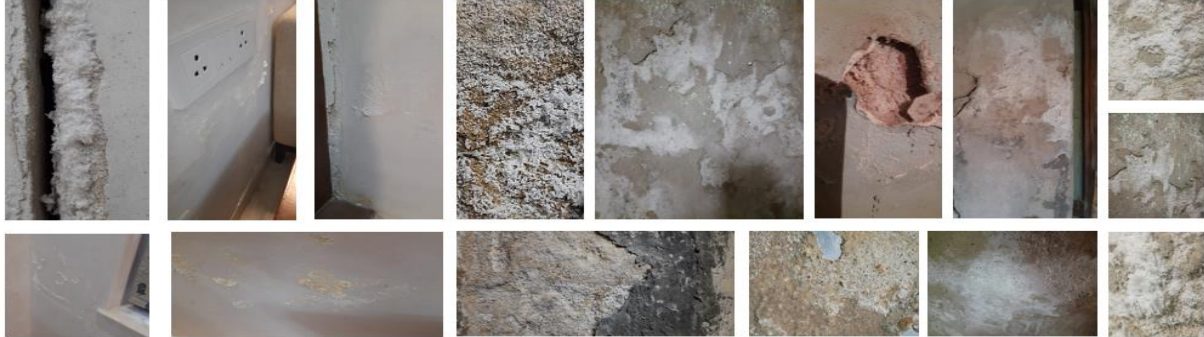
Figure 17 Onsite photos of different locations with mold growth.

From the surveys, it was observed that the hygrothermal behaviour of spaces varied with their characteristics. The spaces were identified based on the topmost finish of the wall surface layer, air velocity inside the space, occupancy, storage, the sunlight received and the type of activity happening in that space. Figure 17 shows photos of different spaces with visible mold growth.

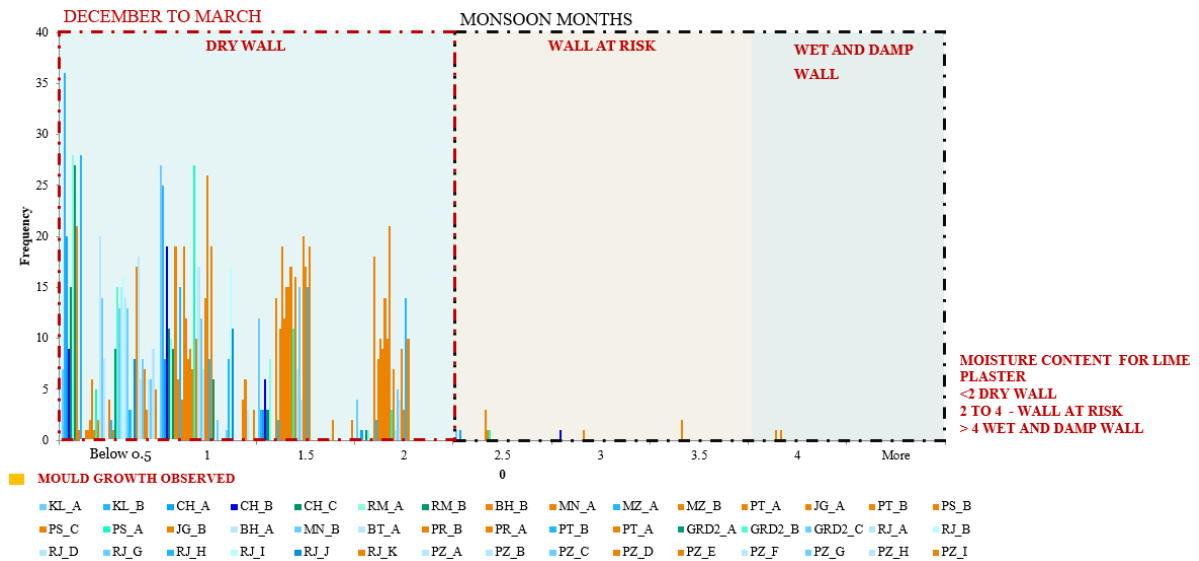
Figure 18 Moisture content of all walls surveyed between December 2019 and March 2020

For further analysis, the moisture content of the walls was recorded and is shown in Figure 18. The walls of the spaces where mold growth is observed are marked in orange. During the study period from December to March, all the walls were dry and showed low moisture content below 2%. However, mold growth was still observed on these walls. The mold would have grown during the past monsoon season from July-October when the RH levels were in excess of 90 % for sustained periods. Factors like damaged construction, presence of water pipelines, low ventilation, etc., were other reasons for mold.

Since the study was conducted in drier months there were hardly any walls having a moisture content of more than 2%. Nonetheless, mold was present on these walls which can further be analyzed by understanding the correlation of moisture content with the surface relative humidity. In Figure 19, the wall moisture content is plotted against the indoor surface relative humidity. The points marked in orange, ochre, red, and maroon represent the readings of walls having mold. The rest of the points are shown in blue colour. The graph is divided into six sections by referring to the characteristic curve of lime mortar in the moisture meter (43). For surface humidity above 60% and moisture content above

2%, there are definite chances of mold. For relative humidity below 30% and 1.5 moisture content, the conditions are dry enough to restrict mold. Walls with mold showed moisture content greater than 0.5%.

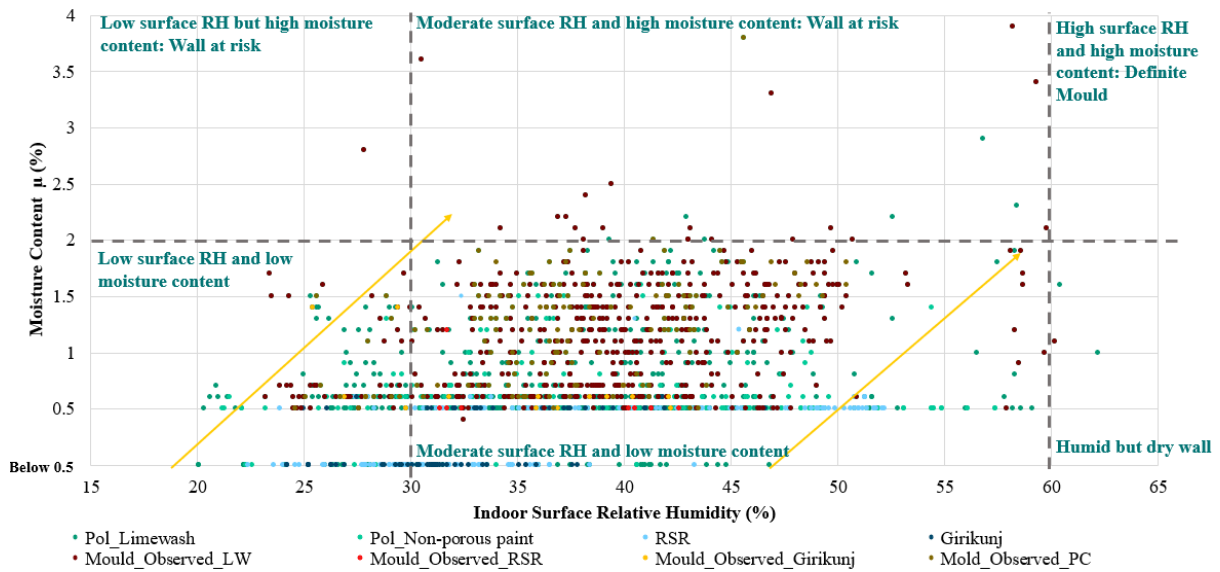
Figure 19 Moisture Content vs surface relative humidity

In case of Pol houses, most of the readings in Figure 19 are populated in the section of moderate humidity and drywall. These also include walls affected by mold due to the predated wet monsoon season. Thus, the poor performance of the building during monsoons or due to specific damage is evident. Points lying below 60% surface humidity and above 2% moisture content suggest mold growth due to the trapped moisture in the walls. Points in bright red are of RSR residence, where the reason for the presence of mold was the existence of a water pipeline and high moisture source (pool) outside the space. In Girikunj residence (marked in dark blue) the mold was observed in the basement and space attached to the terrace. Due to leakage near the slab of the terrace during rain, the walls might have been damaged. There are numerous blue points observed towards the right of the graph indicating well-ventilated and undamaged walls. Overall, a gradual shift towards the right is observed with the increase in indoor surface relative humidity. This indicates the increase in moisture content with the increase in the indoor surface relative humidity.

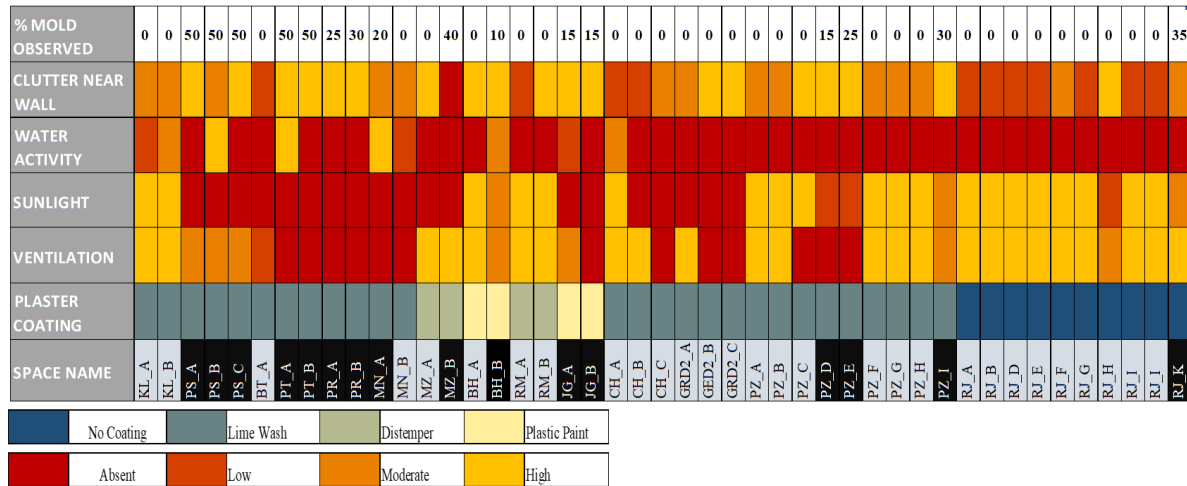
Figure 20 Space characteristics and mold growth relationship

Figure 20 shows the mold scenario of each space with respect to its characteristics. It helps in identifying the strongest and most common factors that affect mold growth as observed and measured during the multiple site visits. The spaces highlighted in black are indicative of mold growth. All the spaces were further categorized and color-coded as per the following characteristics:

- Plaster paint: coating used over the plaster-like lime wash paint, distemper paint, plastic emulsion paint, or not coated. If the topmost coating is nonporous, the moisture is trapped inside, resulting in mold growth.
- Ventilation: if the wall surfaces are not properly ventilated, the moisture inside the pores of the finishing layer doesn't evaporate and leads to mold growth.
- Sunlight: Sunlight plays a role in killing bacteria and keeping highly humid surfaces dry.
- Water Activity: high water activity i.e., activities like washing, cleaning, etc., result in higher moisture inside the space.
- Clutter near the wall (storage): more stuffed spaces create humid pockets inside the space. Clutter is considered low, moderate, and high if the furniture and other items are blocking the walls by 30%, 60%, or 70%. This was based on just visual observations.

The best and worst combination for predicting mold risk can be inferred from Figure XYZ. For example, the worst-case scenario was observed in spaces PT_B and PT_A. More than 50% of the walls were densely covered with mold. PT_B has a good scope of ventilation, but the openings were always closed. So, it can be marked as less ventilated, with no sunlight, no water activity, moderate storage near walls, and a limewash coating on the wall. Even though there was no water activity, other factors were dominating. The PT_A space was characterized by closed openings, no sunlight, high water activity, moderate storage near the walls, and lime wash. In both cases, it was observed that due to lack of ventilation and no sunlight the moisture was trapped inside the space which led to mold growth. The best combination is where lime plaster is not coated or coated with limewash, and the spaces were well ventilated and sunlit. The surveys suggest that mold growth in lime plaster was observed if the moisture transfer is obstructed. Therefore, if lime-plastered surfaces are allowed to breathe in ventilated spaces mold growth can be avoided.

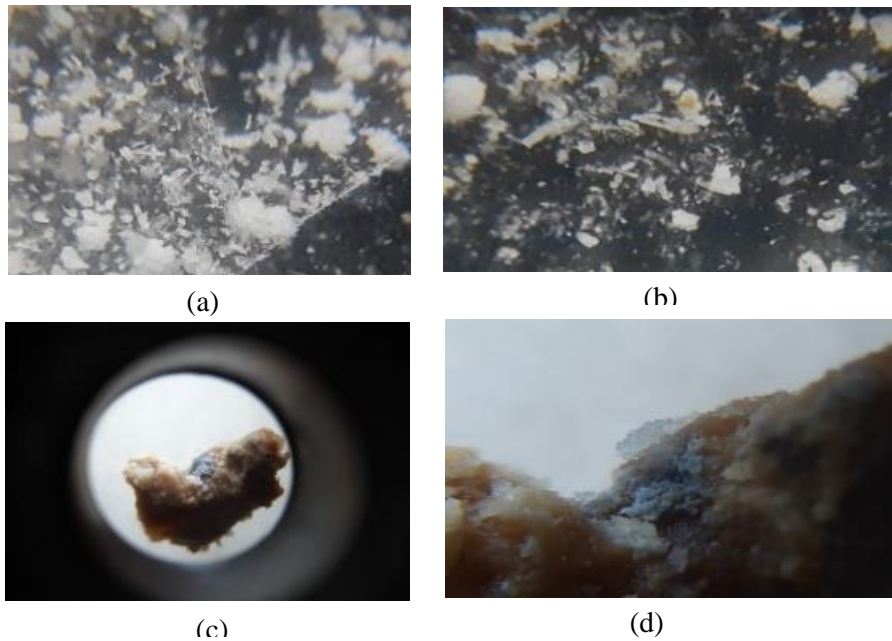
Figure 21 Mold sample under the 40x simple microscope

Samples were collected from the site to verify the presence of mold on the walls. The most common type of mold that is formed over lime plaster was observed. Figure 21 shows the collected samples as observed under a 40x simple microscope. In Figure 21a and Figure 21b, the tread-like filaments are the hyphae of the mold structure. The small granules are likely to be spores. Figure 21c and Figure 21d, show a sample scrapped from a gap between a wooden door frame and a lime plaster wall. This type of mold is different from the one observed on the walls having lime plaster. Observation under a high-resolution compound microscope will be required to identify the type of mold.

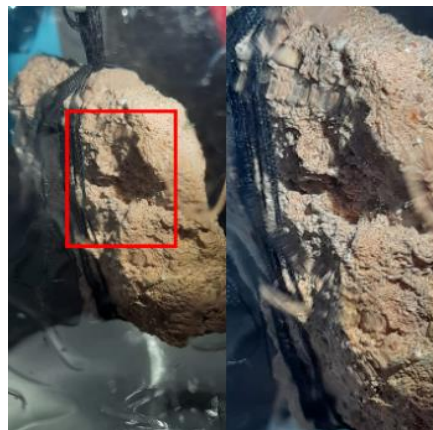
Figure 22 Mold growth observed under 96% relative humidity

All the samples of lime plaster weighed 20 grams and had an initial moisture content of 0.6 %. Of the four containers, the one containing potassium sulphate (96 % RH) had early signs of mold growth. The other three containers (having RH of 75%, 80%, and 86%) showed no visible mold growth until the third week. However, at 96% RH mold growth was visibly seen on the lime plaster sample within three weeks (see Figure 22). Thus, a favourable environment for mold growth is created if the surface relative humidity in the space is more than 90%.
